Town of Canton  
Department of Public Works  
Highway Garage Assessment

March 11, 2013

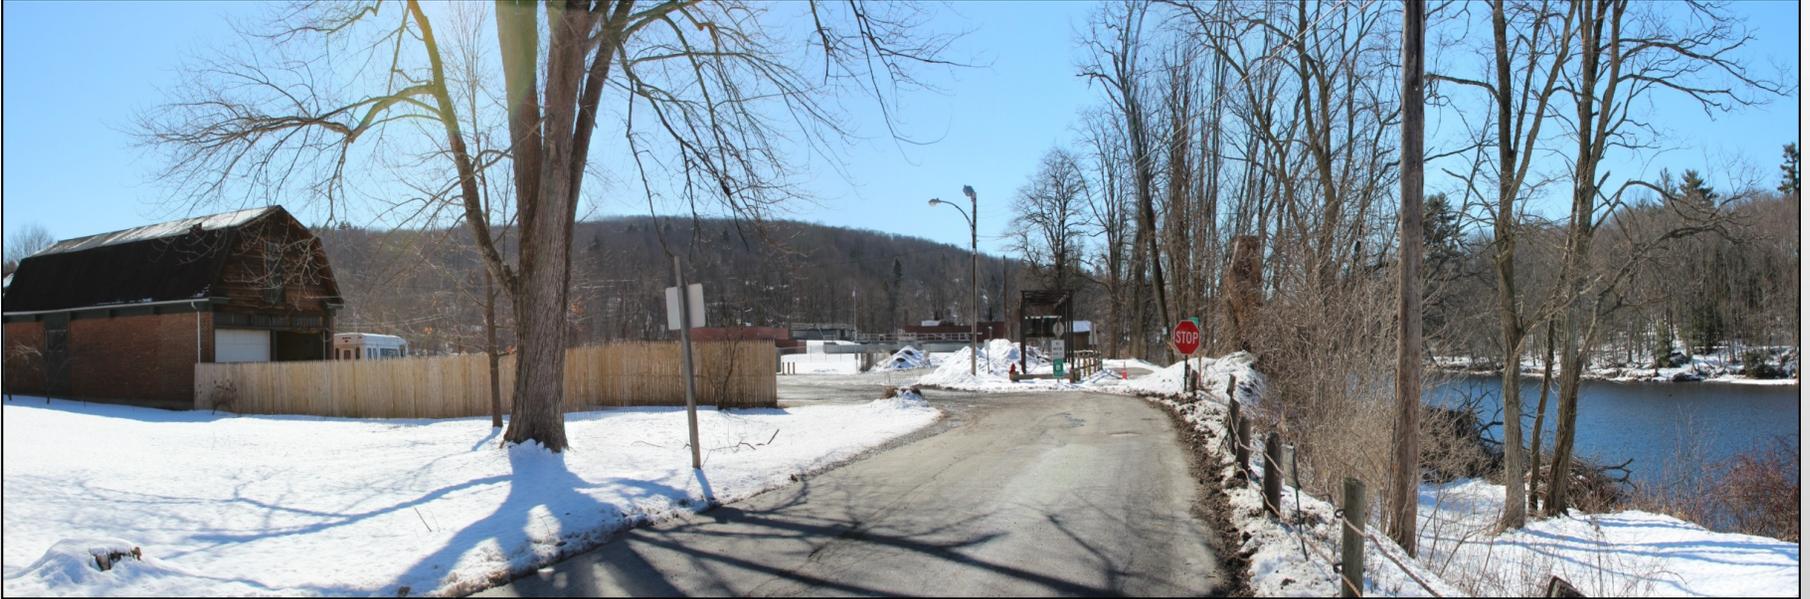
## Flood Plain

Currently the building is located below the base flood line as evaluated by the Federal Emergency Management Agency (FEMA). In the event of a flooding event, the facility would be rendered useless.

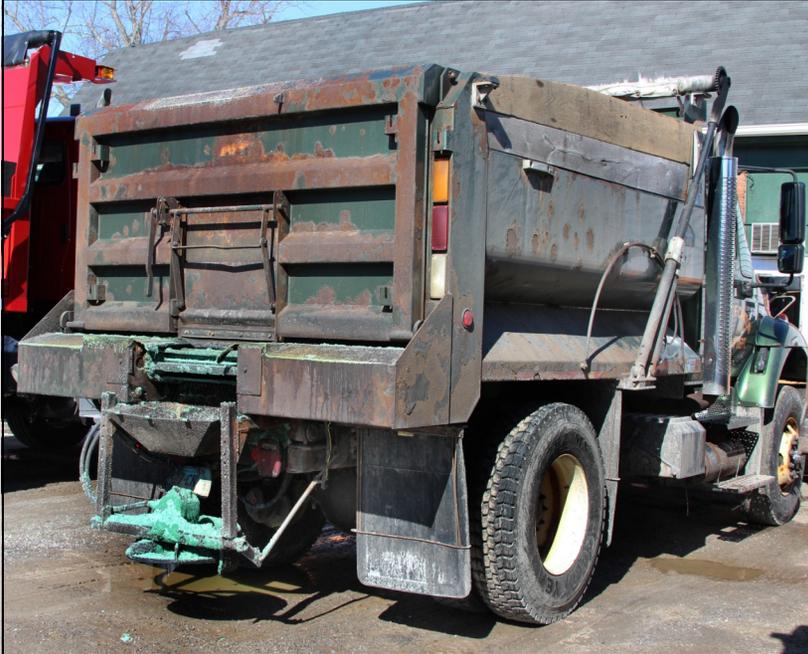
## Washing Vehicles

The State of Connecticut requirements for the washing of vehicles on the site cannot be accommodated without expansion of the existing facility

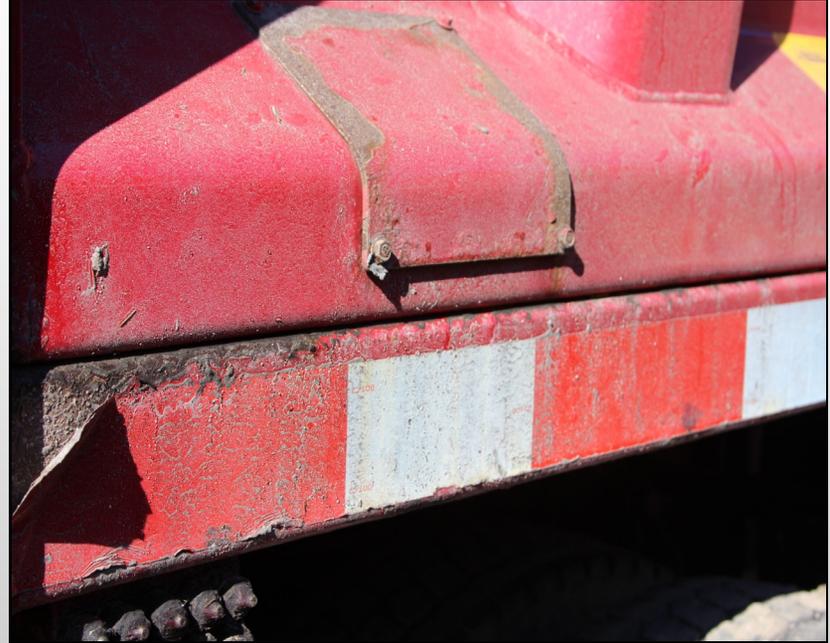
Rust is beginning to develop on the department's 2010 plow truck

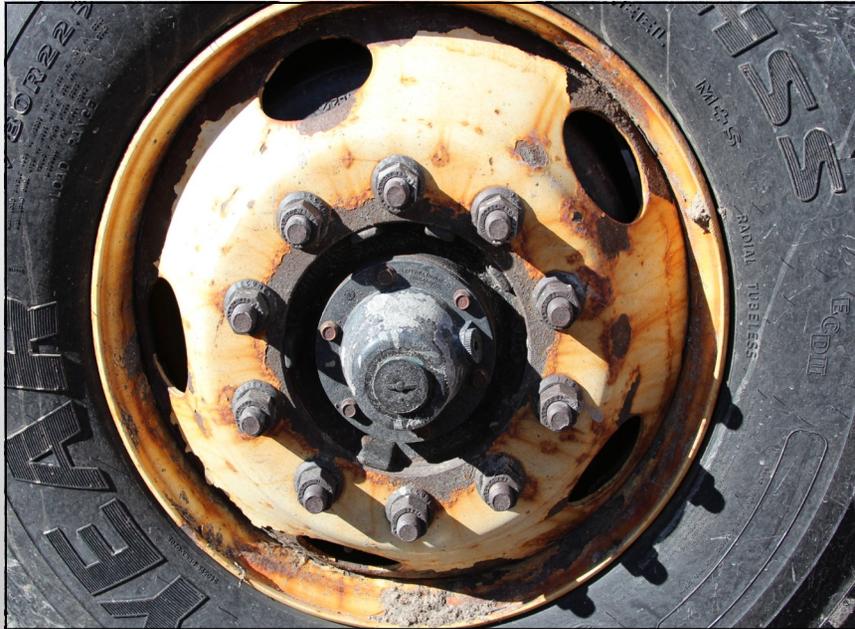
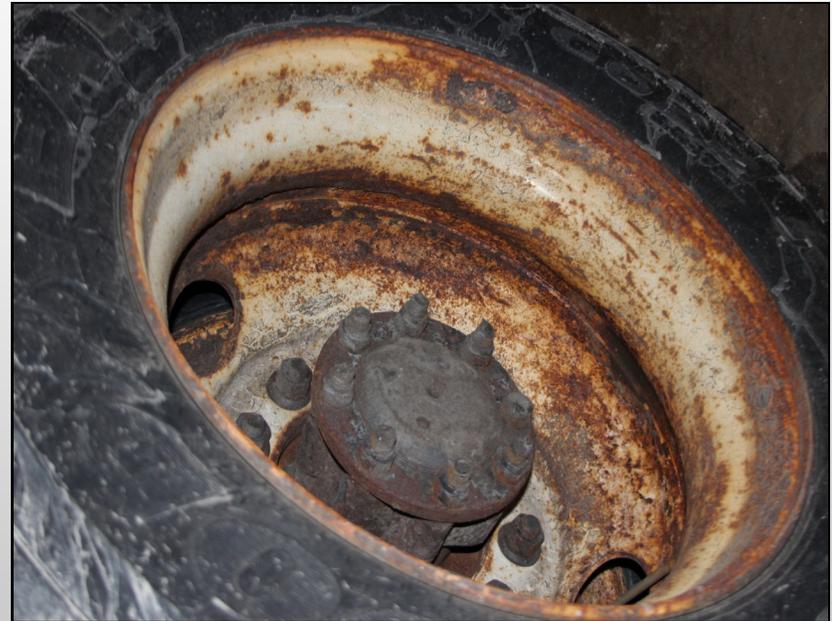
## Wheel Damage

Not being able to properly wash the department trucks leads to wheel fatigue resulting in increased maintenance costs to restore wheels to safe condition.

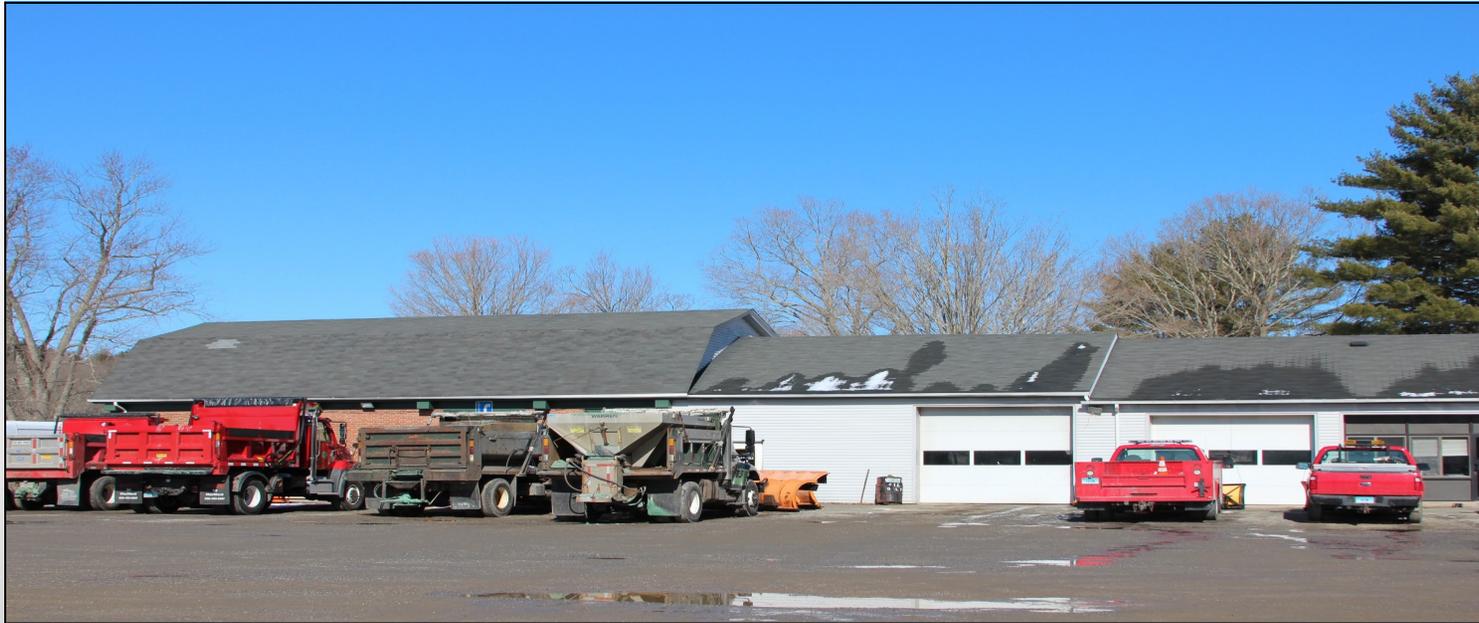
## Vehicle Storage

Currently there is interior vehicle storage space for up to 2 vehicles, requiring that the remainder of the fleet be housed outdoors. Unnecessary exposure to harsh weather conditions accelerates the deterioration of the equipment. The exterior storage of vehicles requires an average of 30 to 45 minutes of vehicle warming up time during cold weather to bring the vehicle up to safe operating temperatures. This delays response times during storm events and can result in unsafe road conditions and public safety concerns. In addition extra time needed for warm up contributes to unproductive labor, wasted fuel, and an increase in pollutants to the environment and surrounding community.

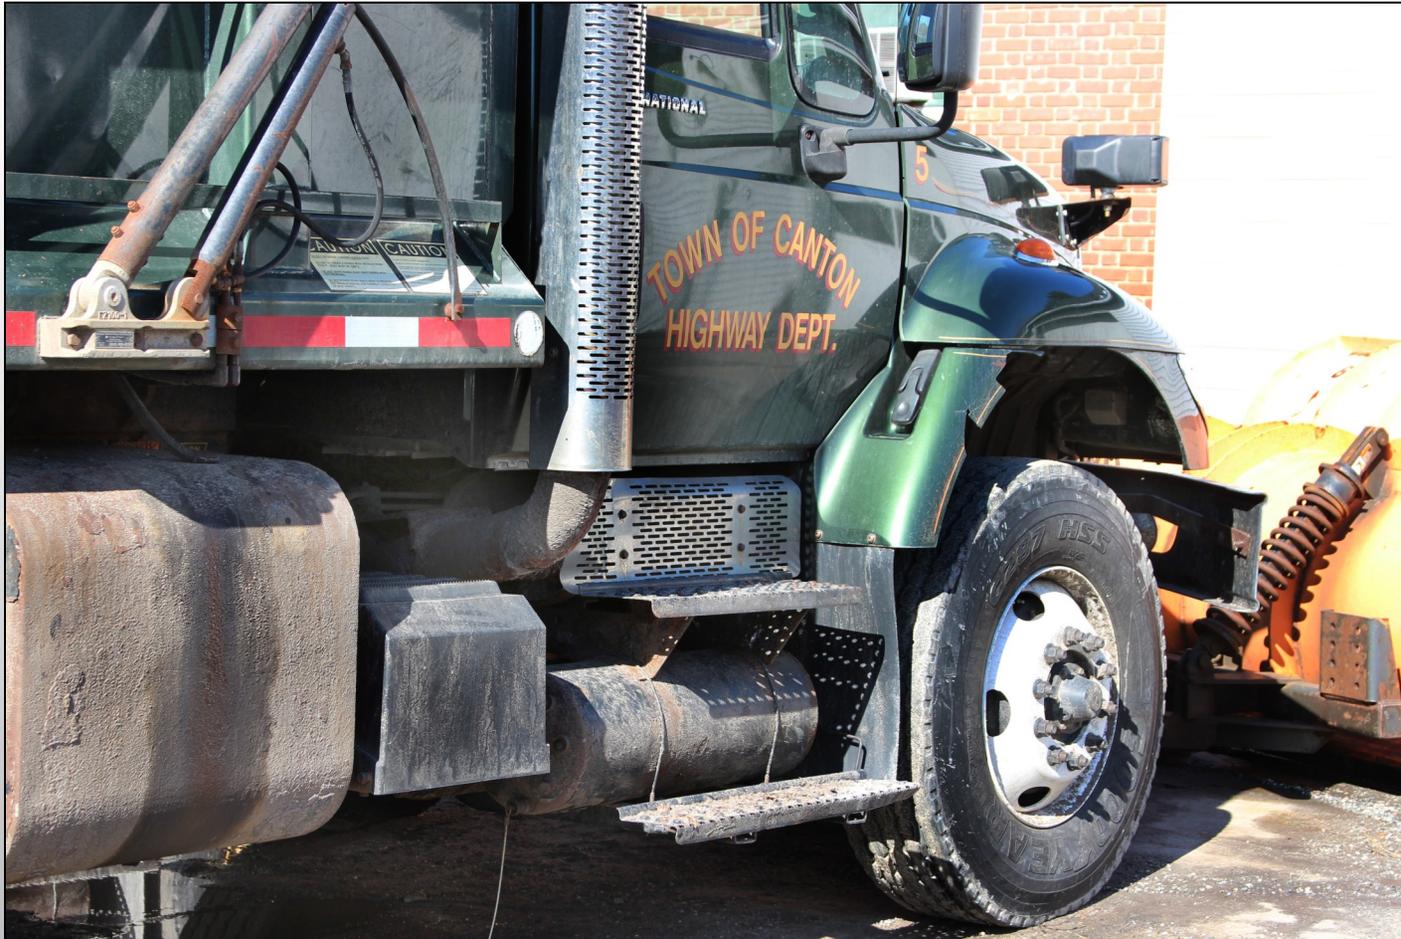
## Diesel Fuel Tank and Air Tank Damage from Storing Vehicles Outside

Tanks develop water inside from condensation resulting in premature damage causing the tank to fail. In the last two years the department has had to replace two fuel tanks (\$950 each) and three air tanks (\$550 each).

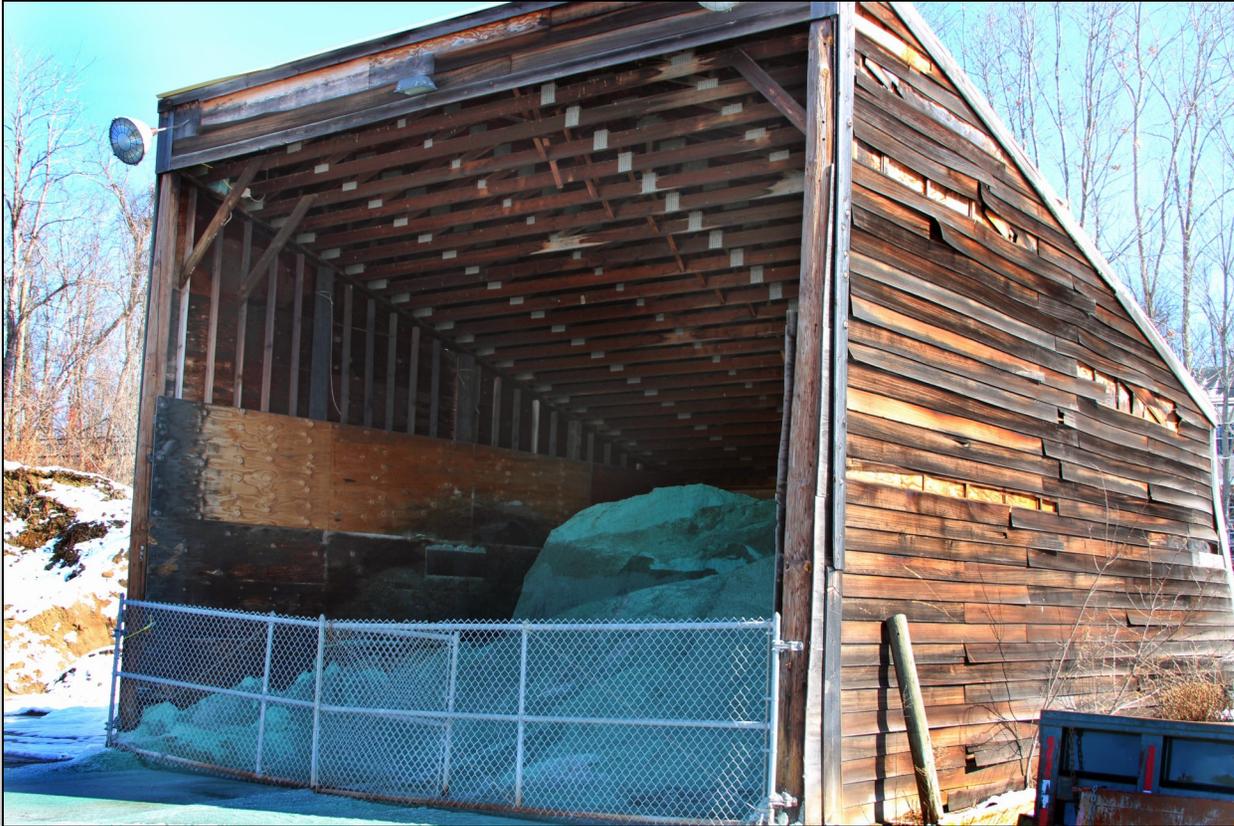
## Salt Shed

With only room to store 200 tons of treated road salt, the inadequate salt storage facility requires the need for a dependency of an off-site storage for salt. Currently the Town has an arrangement with Burlington, which requires that Town of Canton DPW employees travel to Burlington to restock the River Road salt shed. This can result in possible delays in getting salt for storm events of long duration, which in turn may delay road safety conditions for residents. The recent Blizzard in February was one such occurrence.

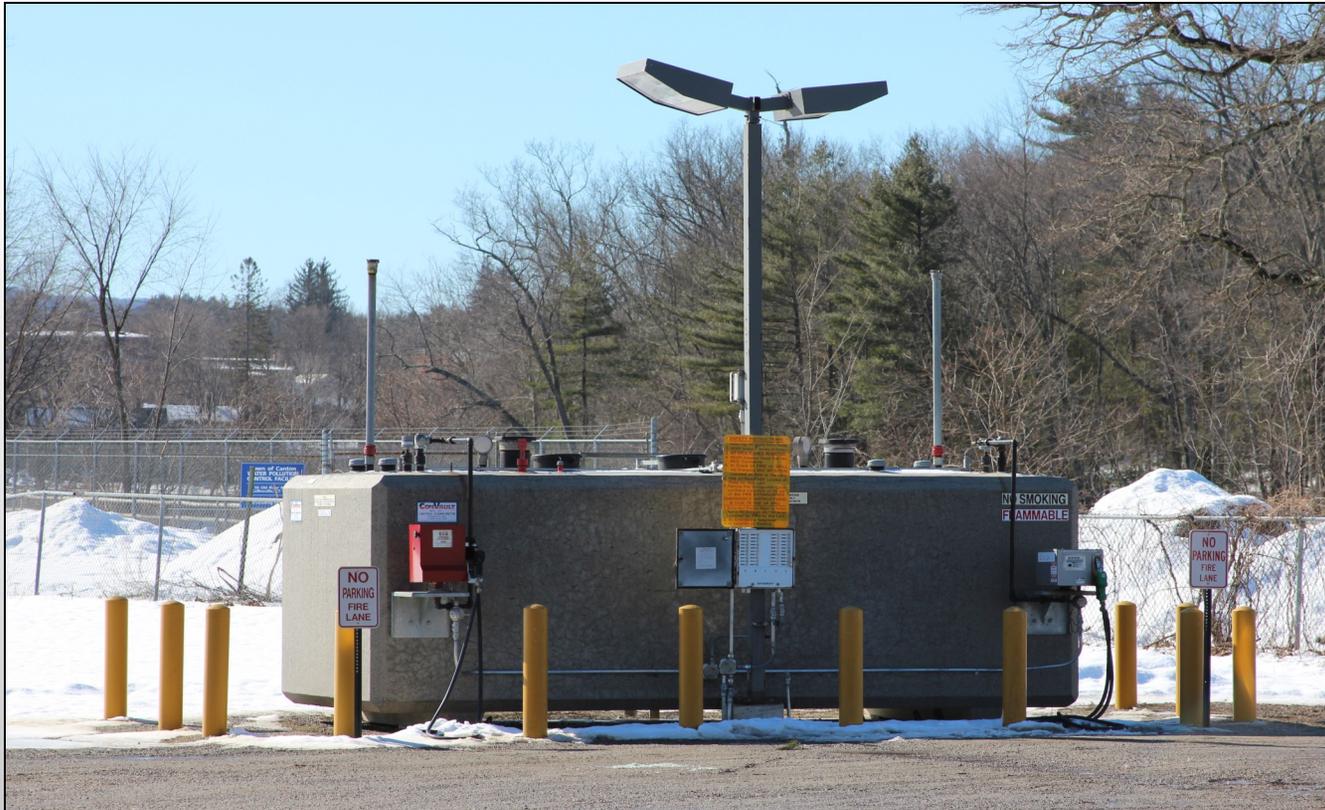
## Gas and Fuel Storage

The current 2,000 gallon gas and diesel fuel storage tanks located at the River Road facility service the Canton Police, Fire, WPCA, Public Works and Board of Ed buses and vans. The storage tank capacity is inadequate. During the recent blizzard in February we ran out of diesel fuel. The pumps are outdated and require constant repair. Parts for the antiquated system are becoming rare, expensive, and difficult to locate. Security and fuel tracking systems which would increase accountability and security are incompatible with the current pumps.

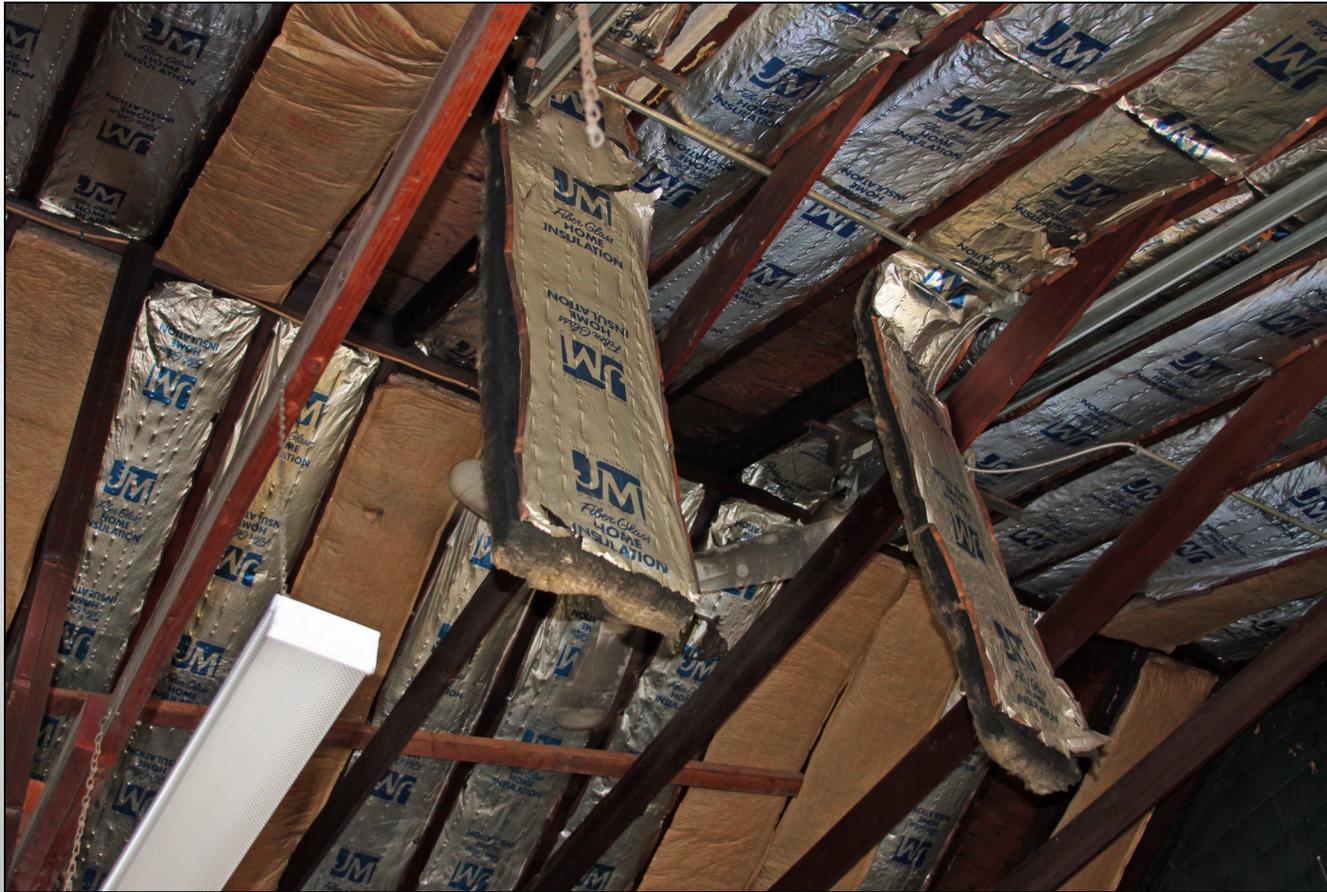
## Deteriorating Building Conditions - Roof

The building is in need of a new roof to eliminate water dripping into lighting and damaging insulation.

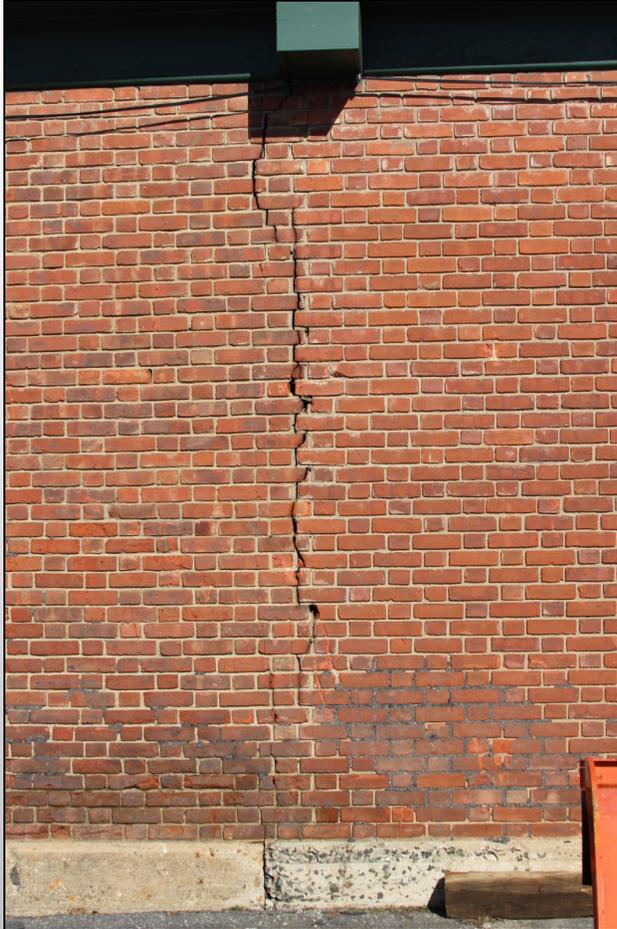
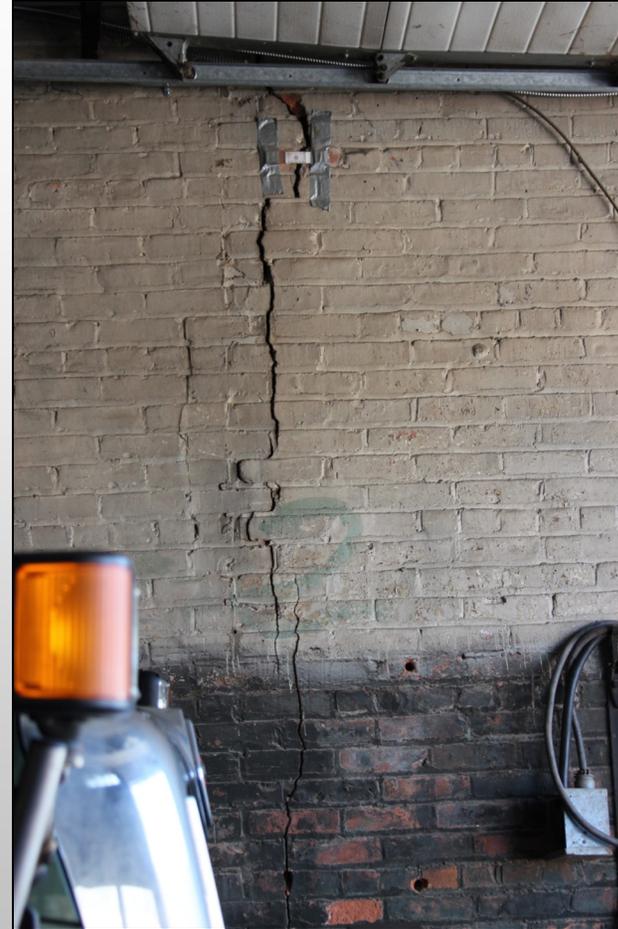
## Deteriorating Building Conditions – Wall

South side of the building has uncontrolled cracking due to differential settlement of the wall that could impact the structural integrity of the wall and building.

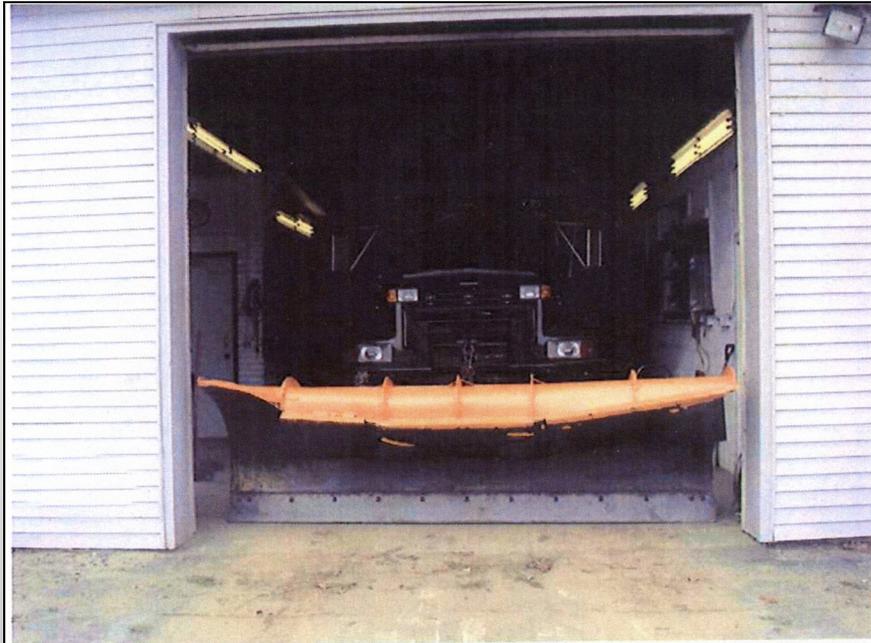
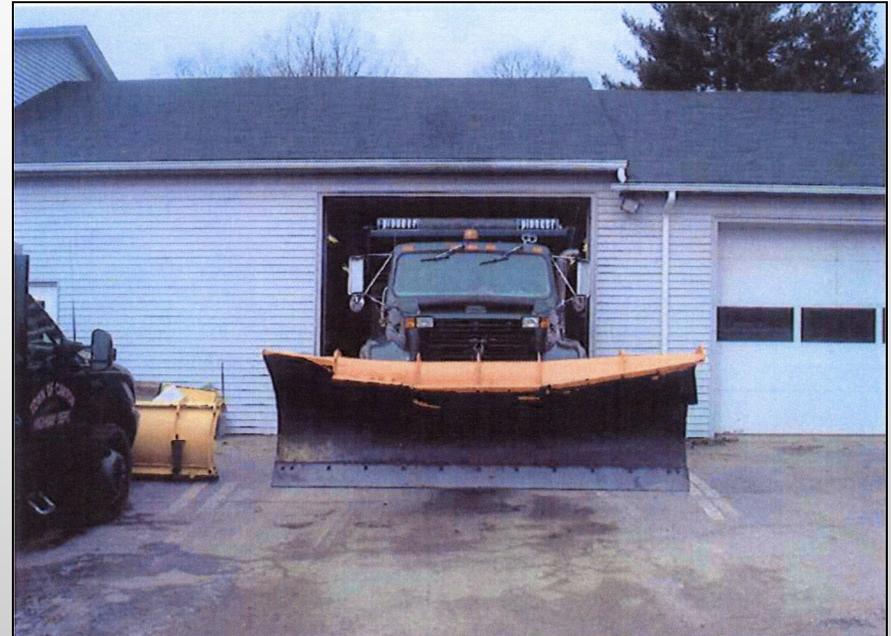
## Vehicle Maintenance

Vehicle maintenance space is overcrowded and inadequate. Large vehicles with a plow attachment do not fit inside the maintenance bay requiring the doors to be open in severe weather. This results in higher heating costs. The work area does not contain a lift making it unsafe and inefficient for employees to work on vehicles.

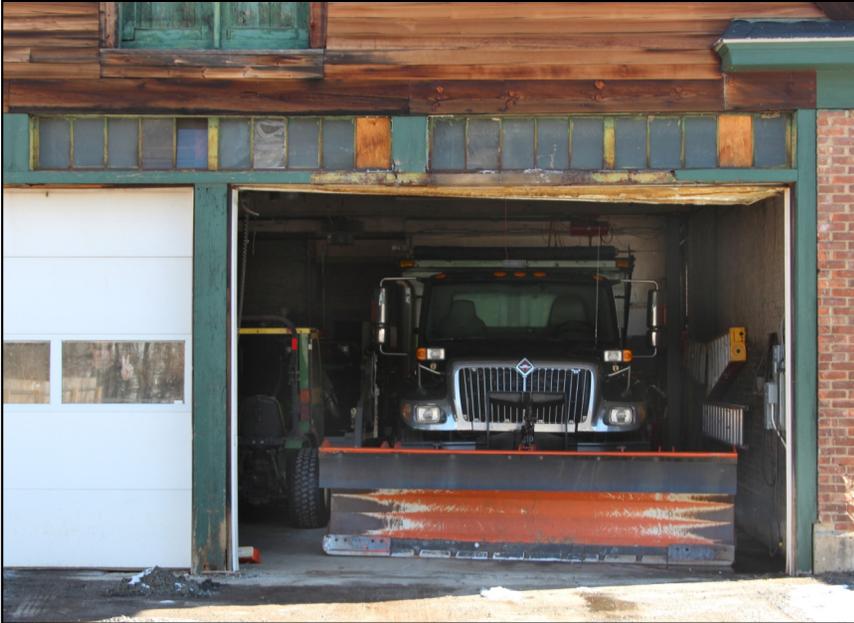
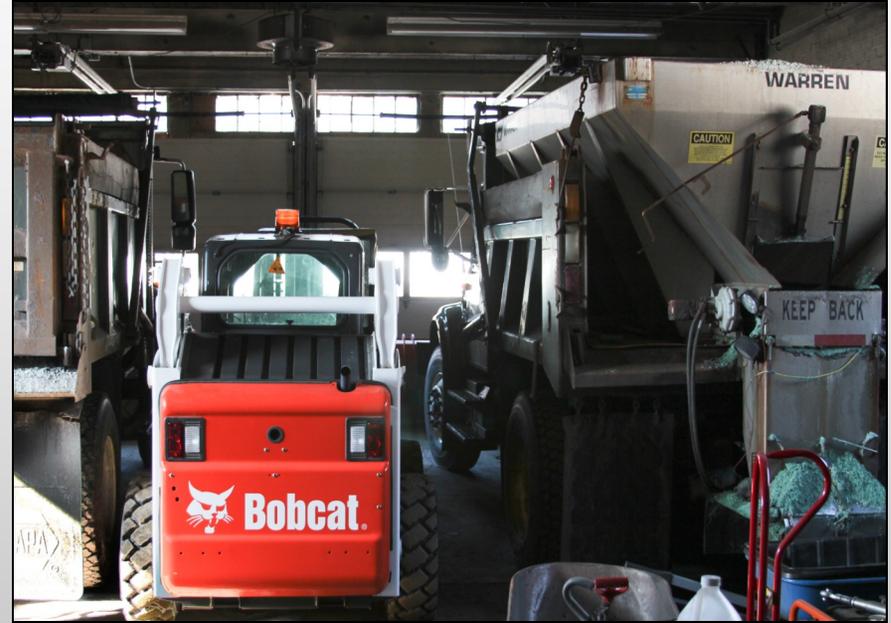
## Equipment Storage

Confined equipment storage areas have resulted in poor egress throughout the building.

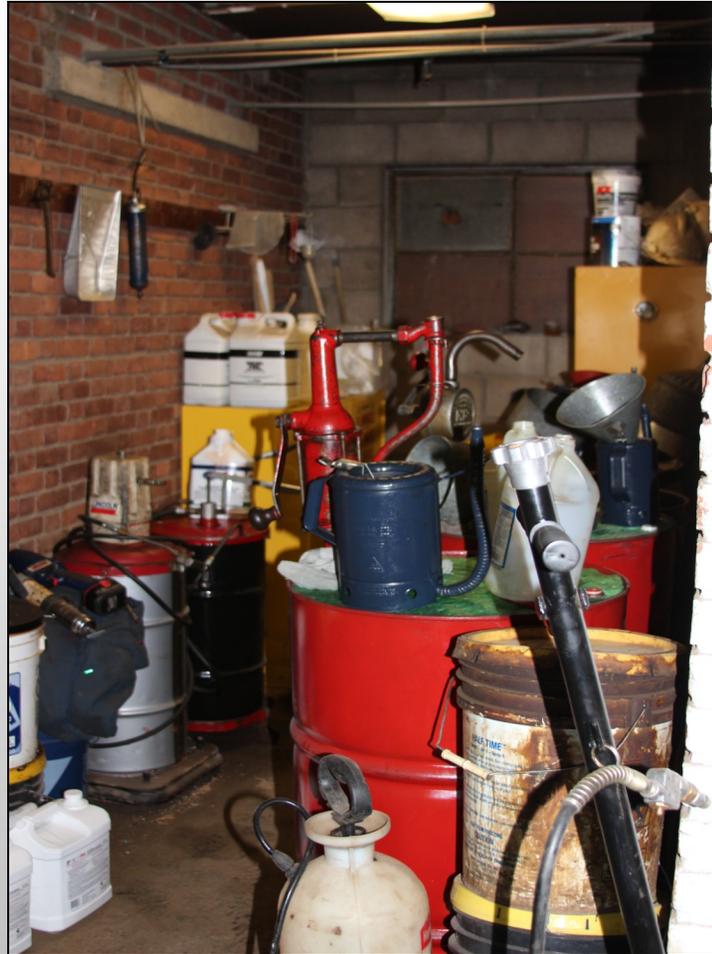
## Materials Storage

Having inadequate storage area results in the limited ability to properly store lubrication and fluid materials causing employees to travel off site to collect the materials or equipment needed for specific jobs.

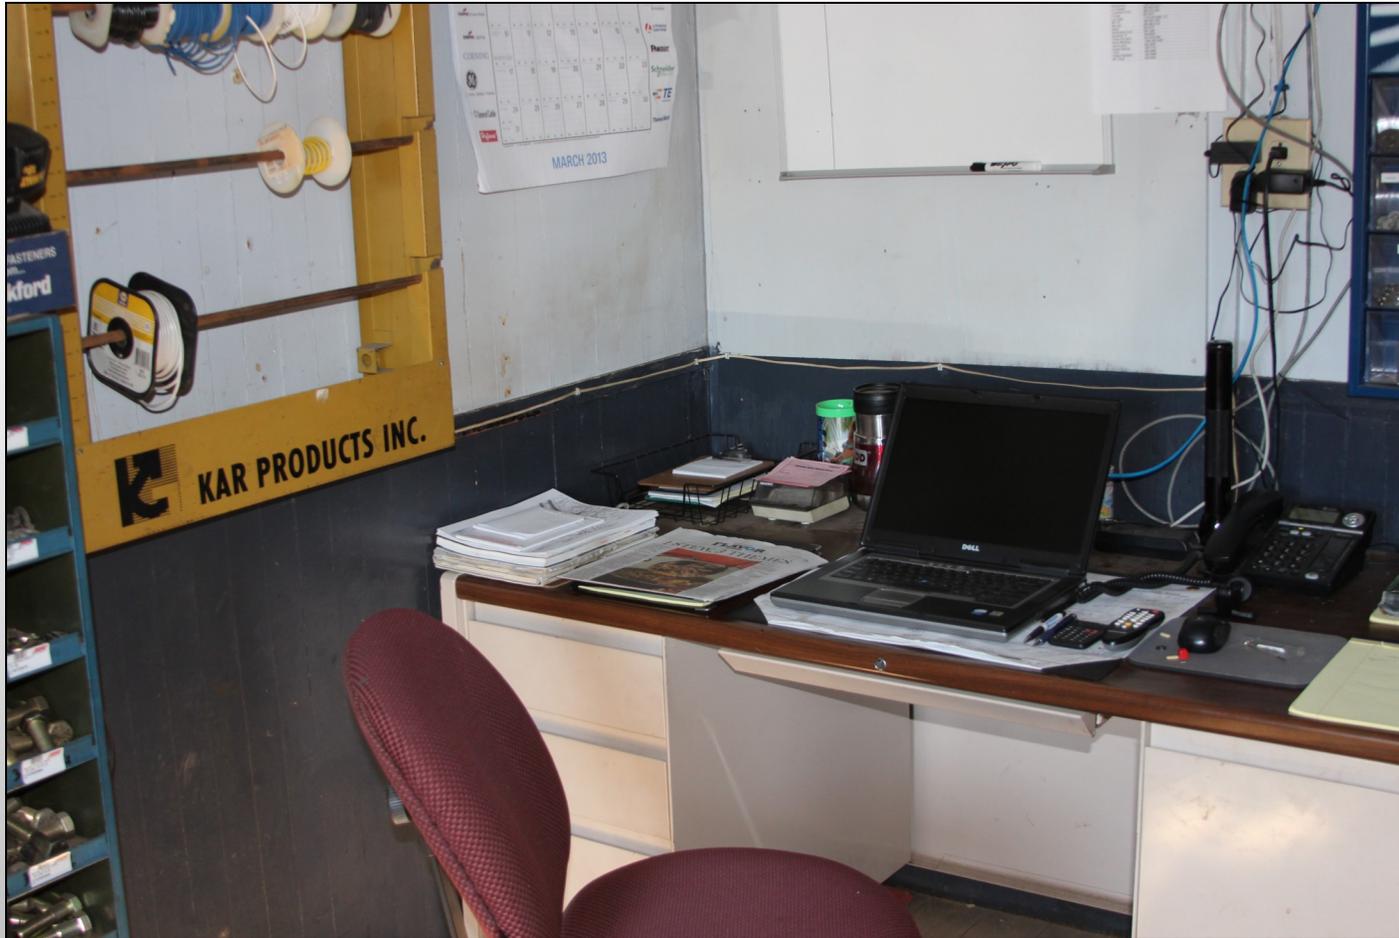
## Office space

There is a notable lack of office space in which to perform daily administrative tasks. This has resulted in the need to share office space with other storage needs. There is no room for an administrative assistant to efficiently serve the public.

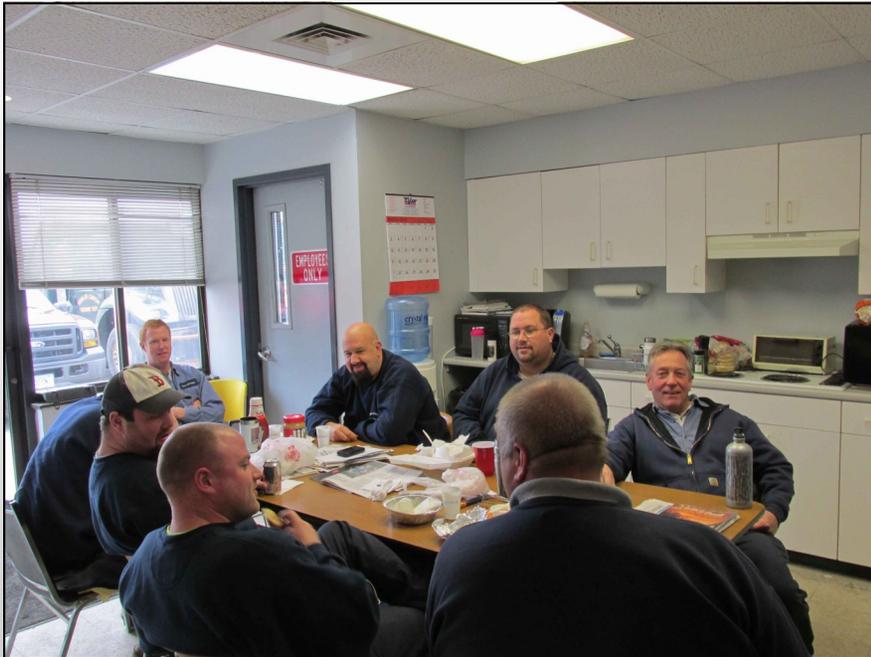
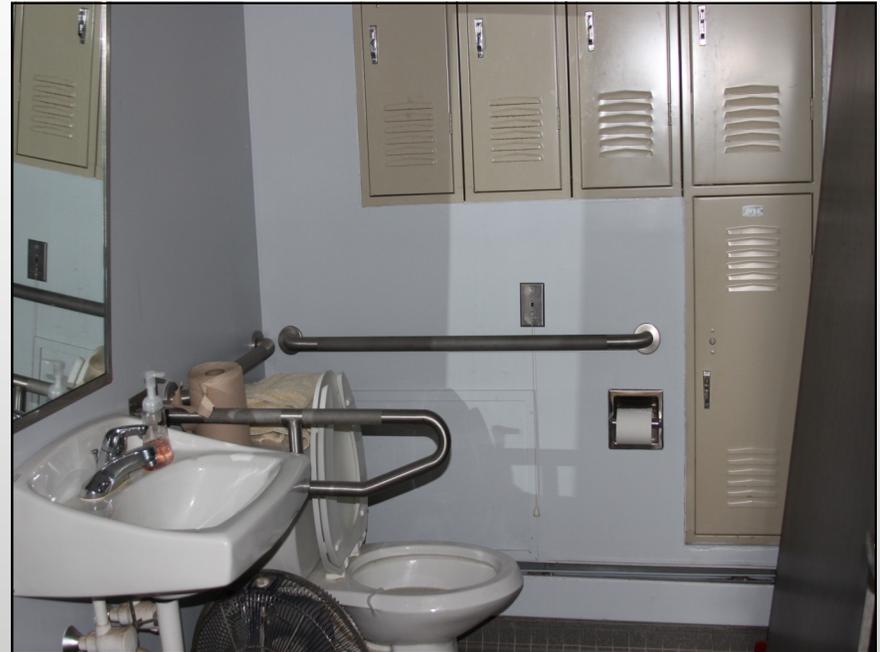
## Employee Areas

Locker room and break areas are undersized. Bathrooms are outdated with little privacy.
