**UPPER COLLINSVILLE MILL POND MASTER PLAN
COLLINSVILLE, CONNECTICUT**

November 23, 2011

MILONE & MACBROOM, INC.
99 Realty Drive
Cheshire, Connecticut 06410
(203) 271-1773
www.miloneandmacbroom.com

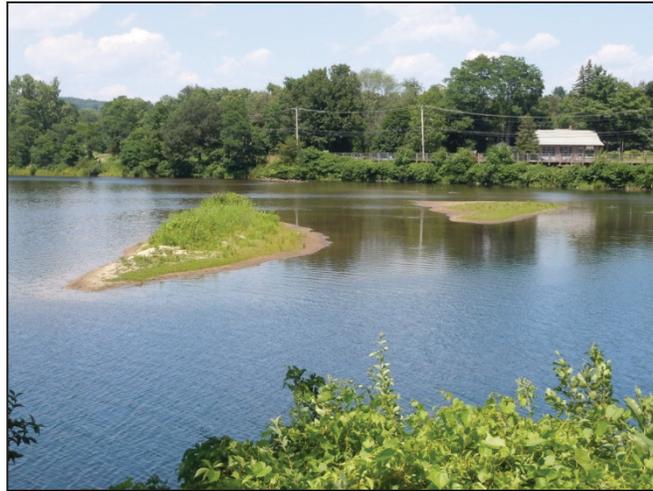
Sediment deposits are creating seasonally exposed bars and islands as well as causing shallow water that reportedly interferes with paddle sports. It has been the public's perception that the area of sandbars and shallow water is one of the most changed parts of the impoundment.

Islands and sandbars near Bridge Street

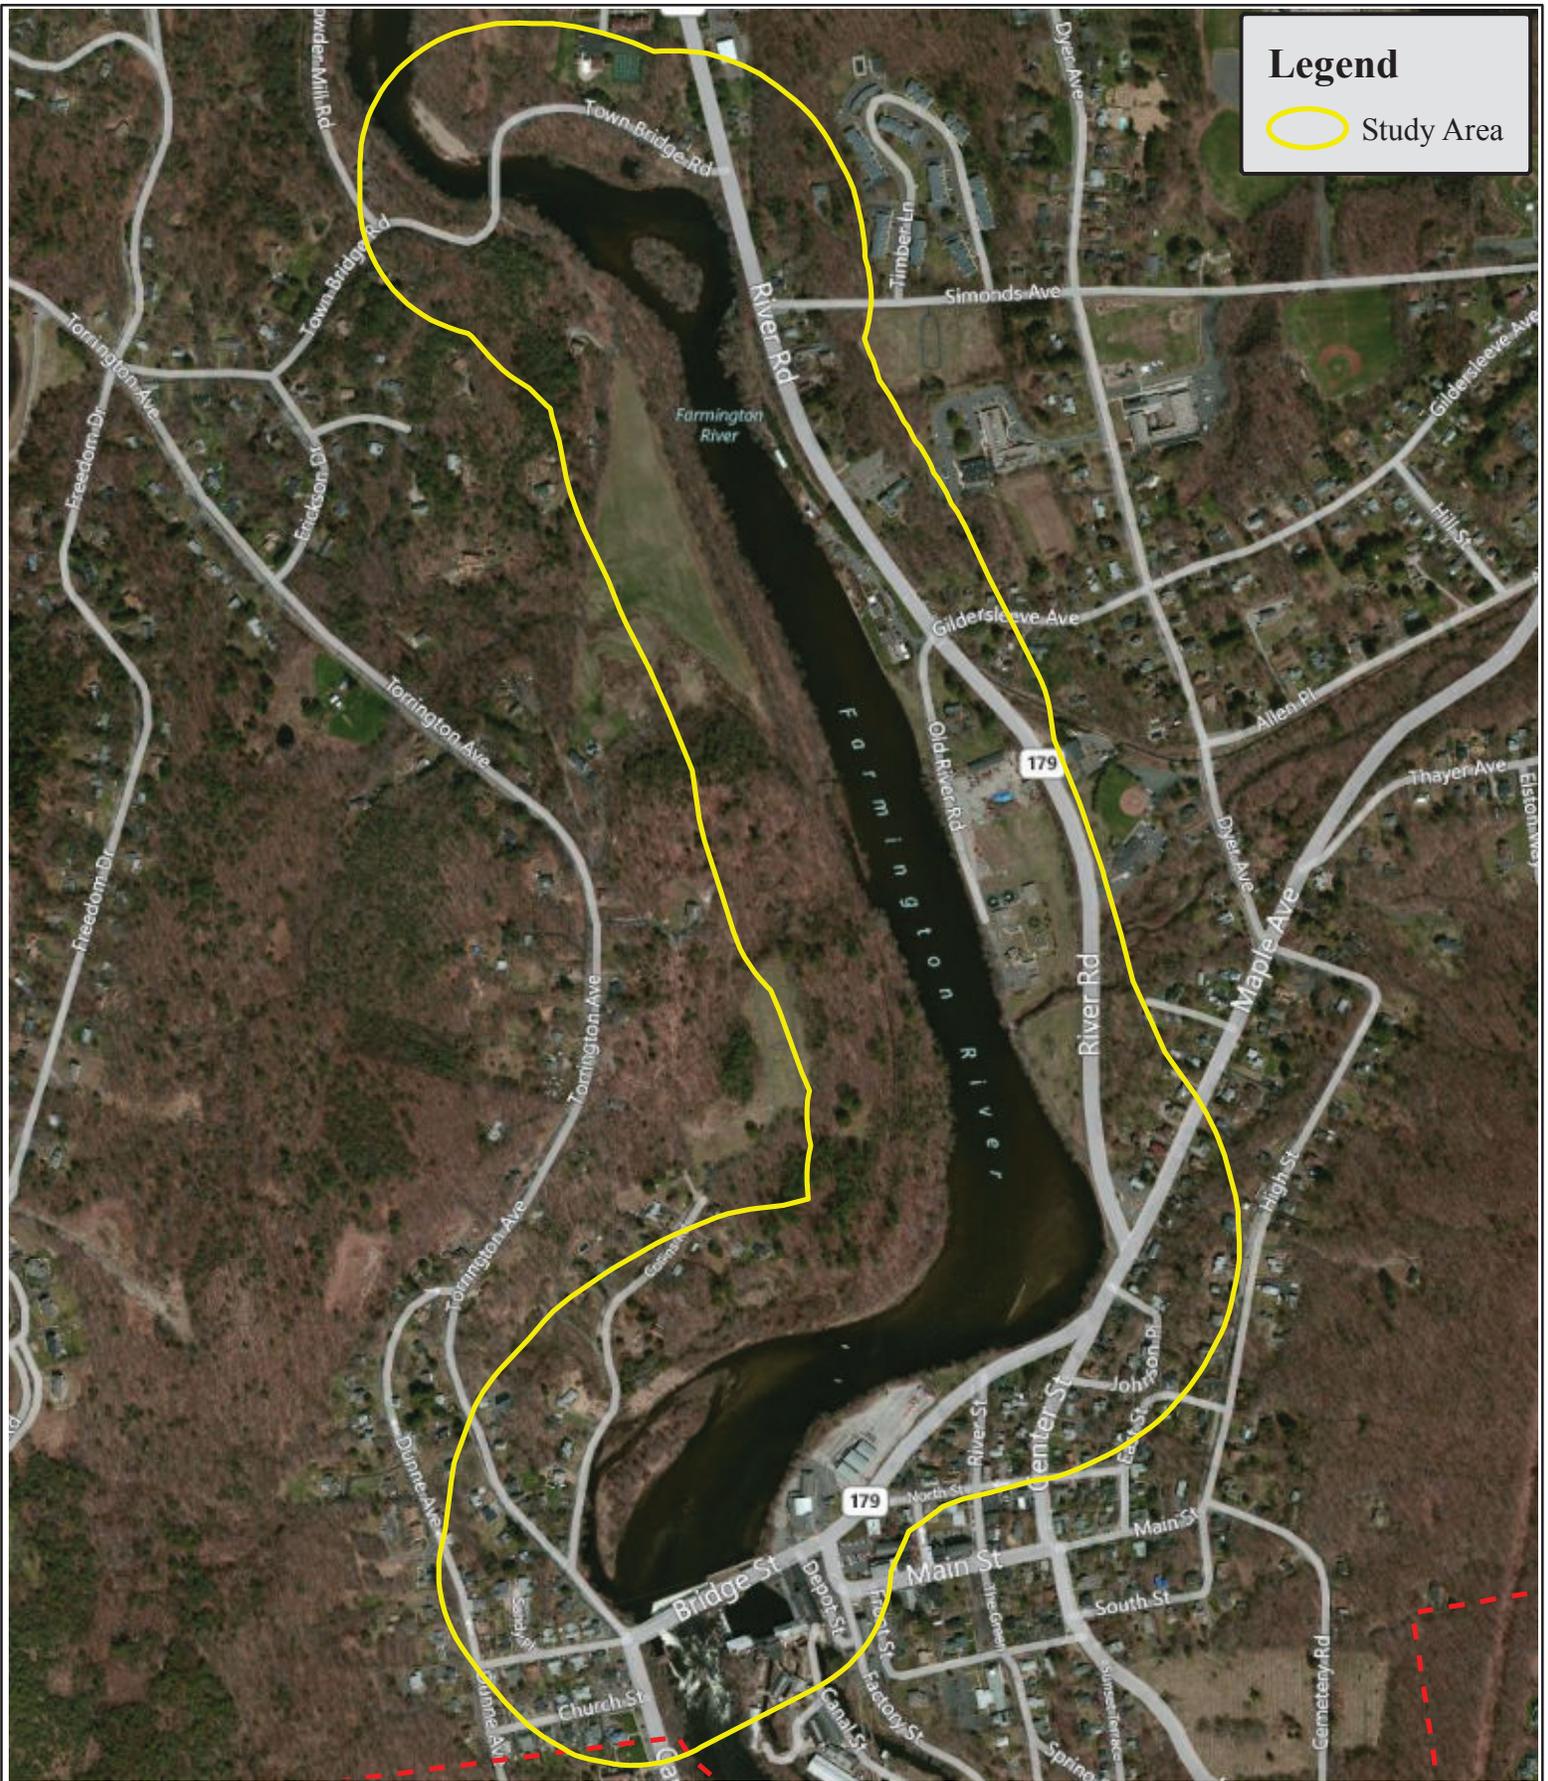
A grant of \$100,000 was awarded to the Town of Canton to develop the "Upper Collinsville Mill Pond Master Plan." According to the award announcement, the master plan shall include "a feasibility study for removal of sediment from the Upper Collinsville Mill Pond located upstream of the Upper Collins Company Dam on the Farmington River for restoration of recreational, aesthetic, economic, historical and ecological value of this portion of the Farmington River and to provide a master plan for restoration activities." The master plan scope is constrained to a "study area." The study area includes the impoundment from Bridge Street to Town Bridge Road, and land areas within 500 feet of the edge of high water. Refer to Figure 1-1.

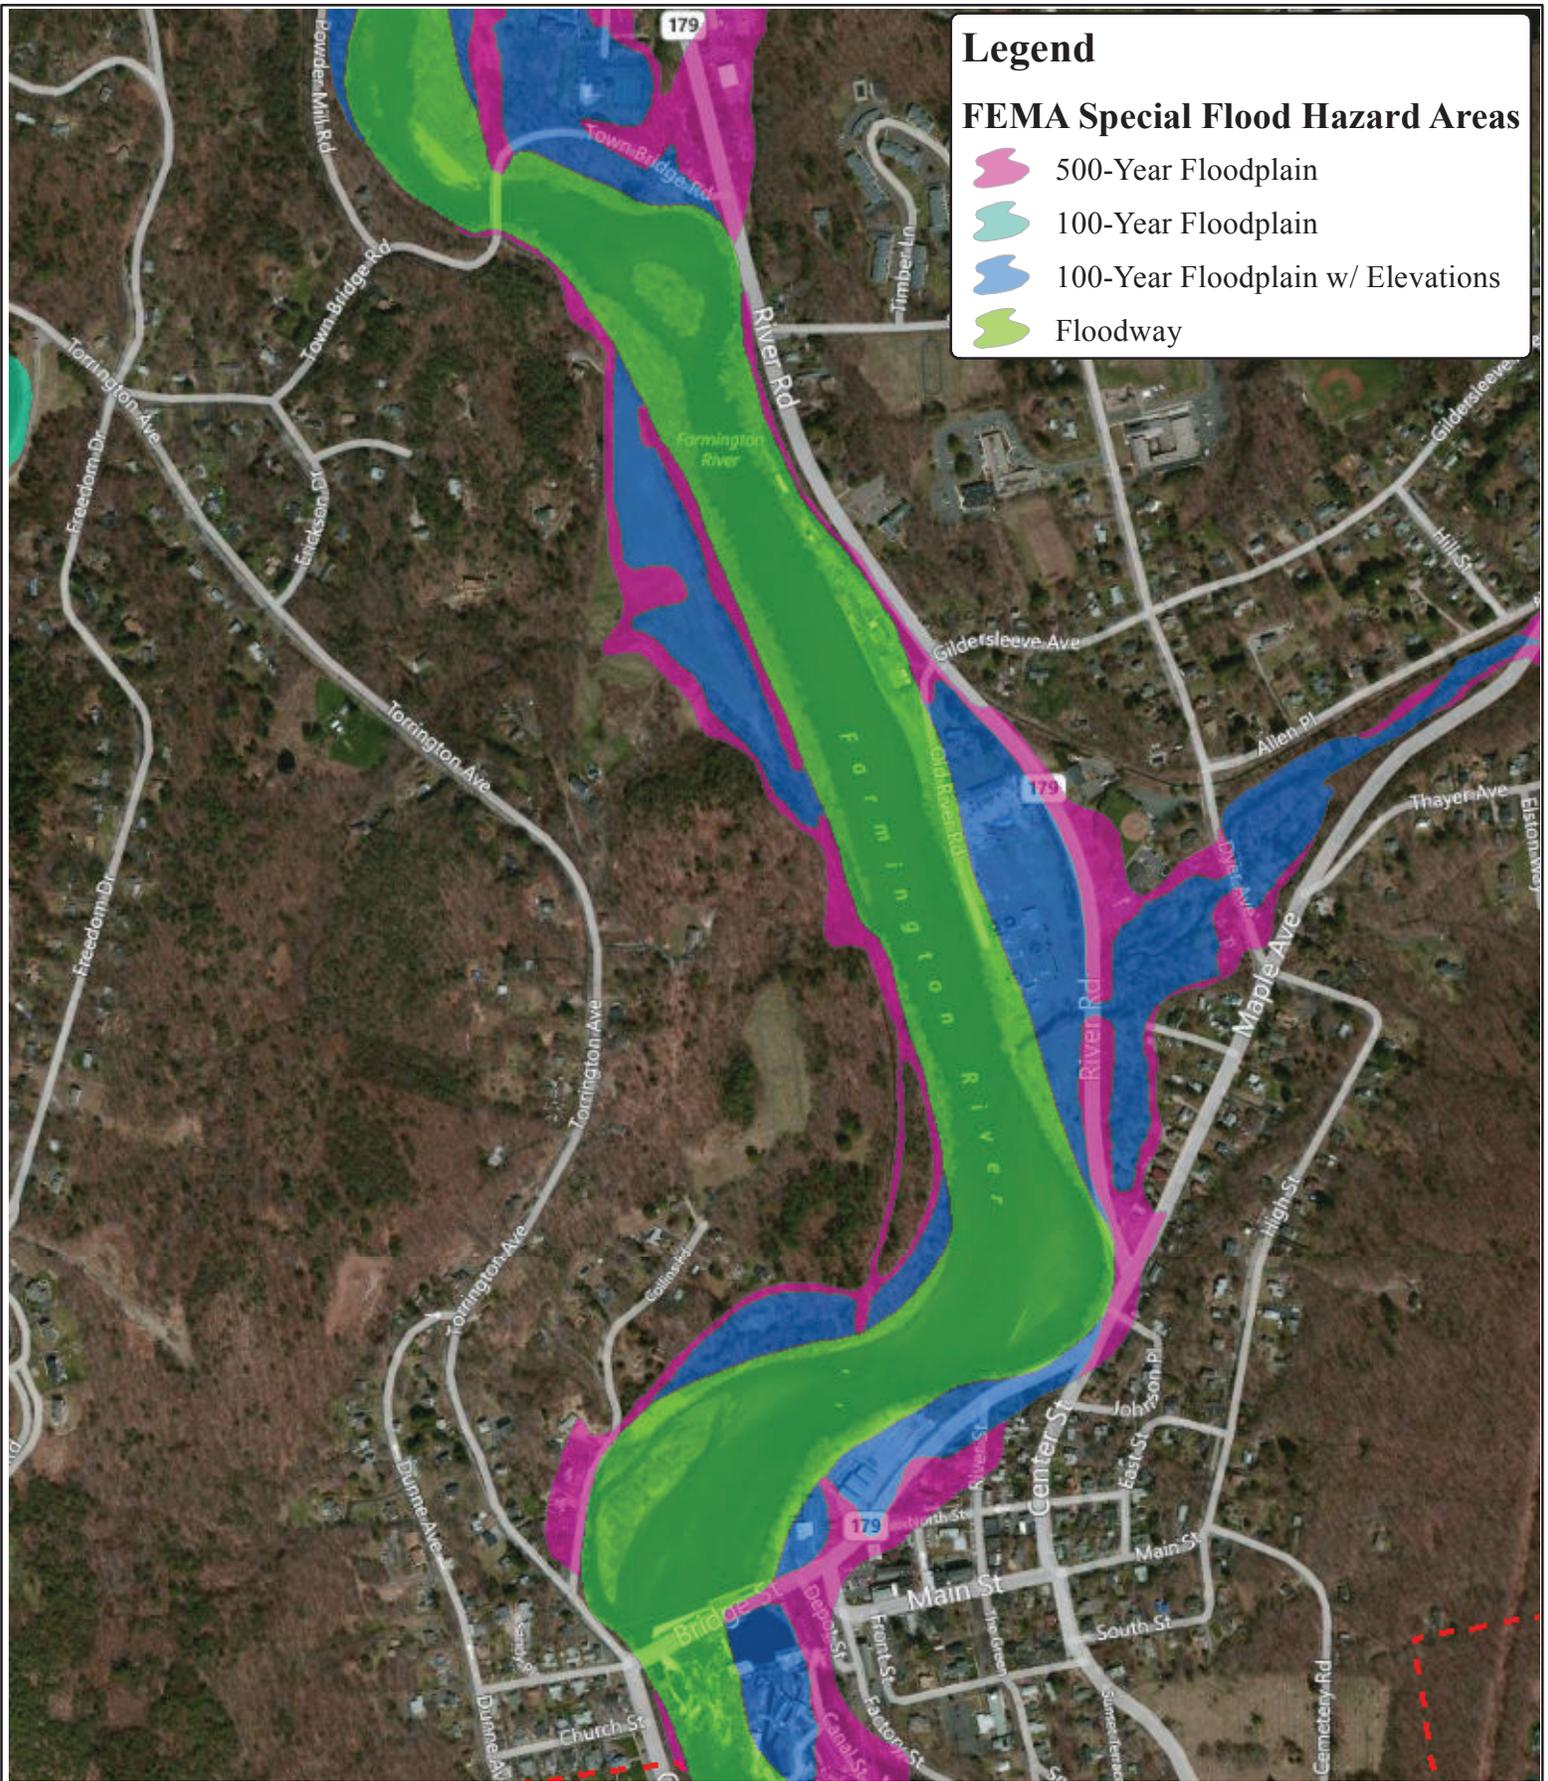
Figure 2-1 presents the Special Flood Hazard Areas (SFHAs) and regulatory floodway along the Farmington River and the Upper Collinsville Mill Pond. The SFHA is commonly known as the 100-year floodplain and is the area covered by the base flood. The base flood is the flood that has a 1% chance of occurrence in any year. The regulatory floodway is the portion of the SFHA that is needed for conveyance of floodwaters. The regulatory floodway is typically assigned by the Federal Emergency Management Agency (FEMA) by determining the portion of the river where floodwaters would rise a certain predetermined amount (such as one foot) if the fringes in the floodplain were filled.

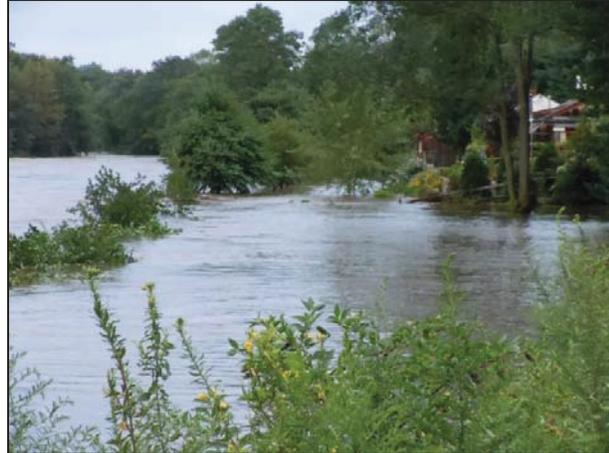
The most recent flooding condition occurred during and immediately after the passing of Tropical Storm Irene on August 27-28, 2011. Although severe flooding did not occur to the extent that structures or property were damaged in the study area, many low-lying areas in the study area were inundated.

Overbank conditions at Old River Road after T.S. Irene

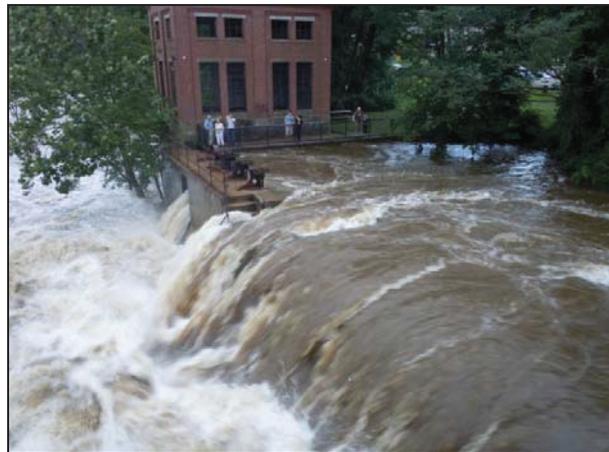
Flooding after T.S. Irene

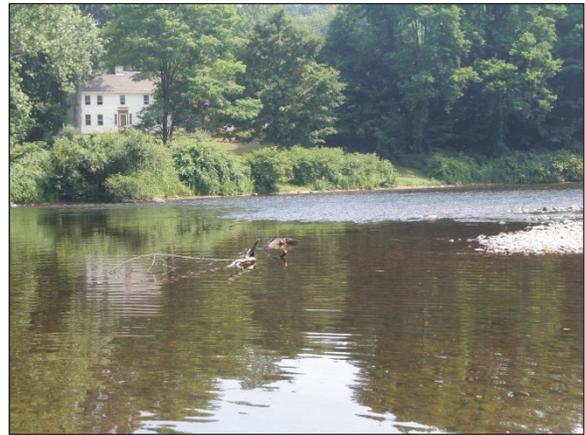
At the current water surface elevation of 286, the backwater of the impoundment does not extend upstream of the island near Town Bridge Road. In other words, there is a low water surface gradient extending from the upstream end of the island to the downstream end of the island. The expression of this gradient is a moderately deep riffle present on the east side of the island.

View of riffle near Town Bridge Road facing downstream

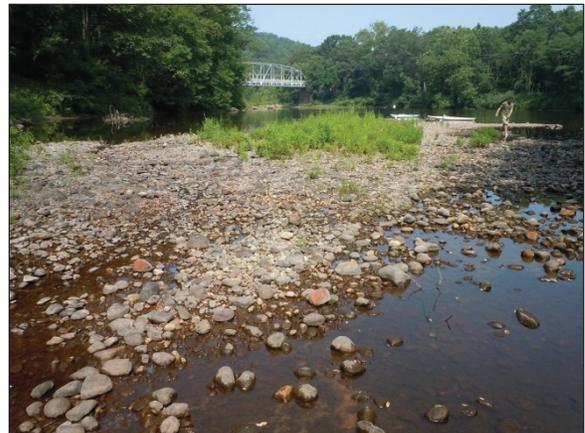
When standing on the dry riffle on the west side of the island, one can see that the water surface on the downstream side is roughly half a foot lower than it is on the upstream side. With the flashboards installed, the gradient in this area was evidently submerged, and the backwater of the impoundment would have extended upstream beyond the Town Bridge Road bridge.

View of dry riffle

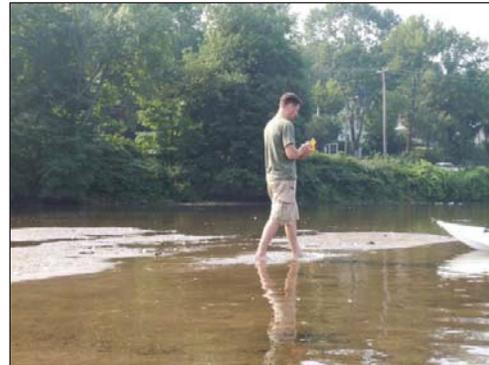
Emerging sandbars

From July 6 to July 17, 2011, the water surface decreased several inches as the discharge decreased from approximately 460 cfs to 350 cfs. From July 17 to July 21, the decrease from 350 cfs to 320 cfs caused a sufficient decrease in water surface elevation such that the third island became exposed near the Bridge Street/River Road intersection.

Other manifestations of changing river discharge rates from spring through summer include small “beach” areas and bedrock outcrops becoming exposed and changing flow characteristics at the riffle in the vicinity of the island near Town Bridge Road.

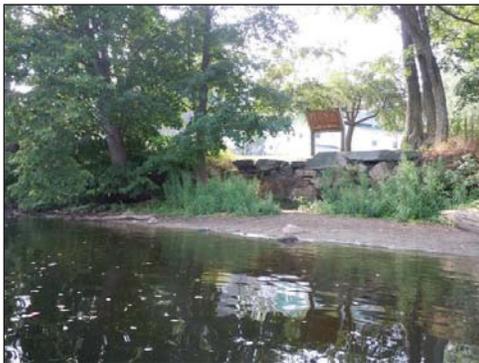
Emerging beach near boat launch and trail

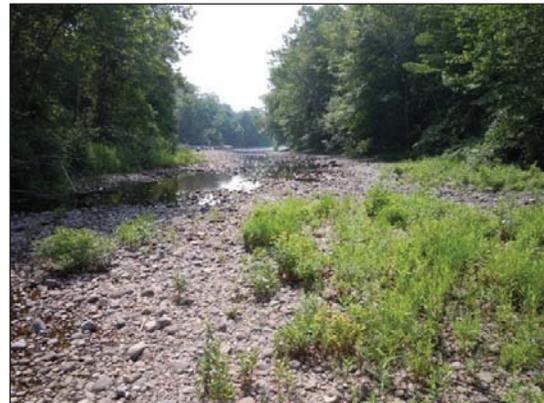
Dry riffle at island near Town Bridge Road

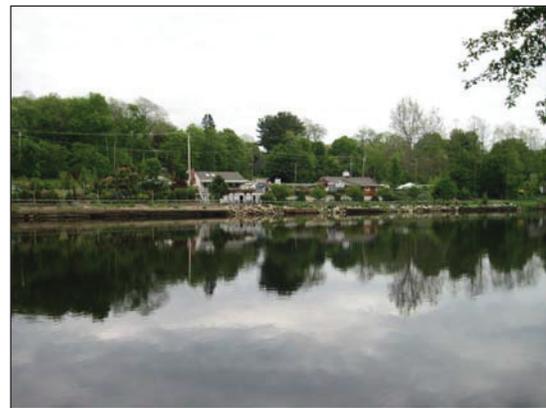
Walls along Riverside Nursery

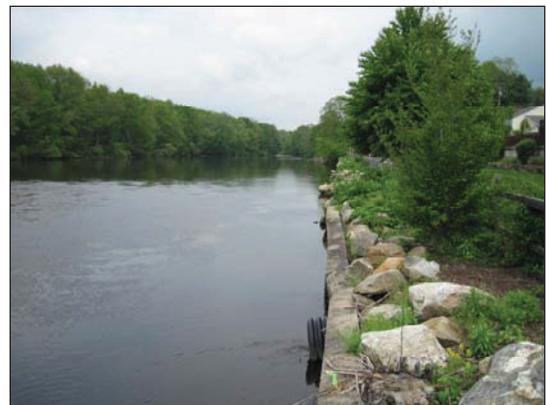
Various pipes and culverts are present in the wall sections, including (from north to south) a 15-inch corrugated metal pipe, a 15-inch reinforced concrete pipe, an eight-inch PVC pipe, a one-inch PVC pipe, a three-inch plastic pipe, two 30-inch corrugated plastic pipes, and two six-inch cast iron pipes. The one-inch and three-inch pipes appear to be intakes, whereas the others appear to be stormwater outfalls or irrigation return pipes.

Pipes in the wall along Riverside Nursery

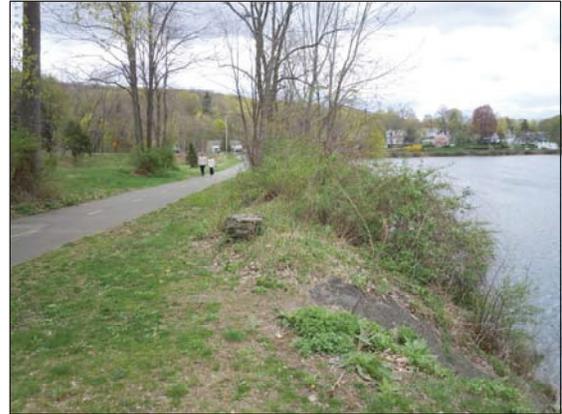
Asphalt patches along town-owned property

Downstream of Rattlesnake Brook, vegetation is comparatively sparse and a few patches of asphalt were observed on the slope between the Farmington River trail and the impoundment.

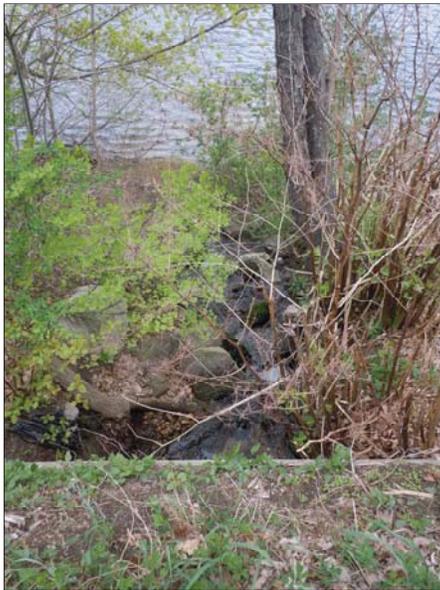
Stormwater outfall near trail

The Farmington River trail is located immediately adjacent to the impoundment along the bend of the river near the River Road/Bridge Street intersection. The riverbank below and downhill from the trail is vegetated and steep. Six stormwater outfalls and stream culvert outlets are located in this span. From upstream to downstream, these are a 24-inch reinforced concrete pipe, an 18-inch reinforced concrete pipe, two 15-inch reinforced concrete pipes, an 18-inch reinforced concrete pipe, a 24-inch reinforced concrete pipe.

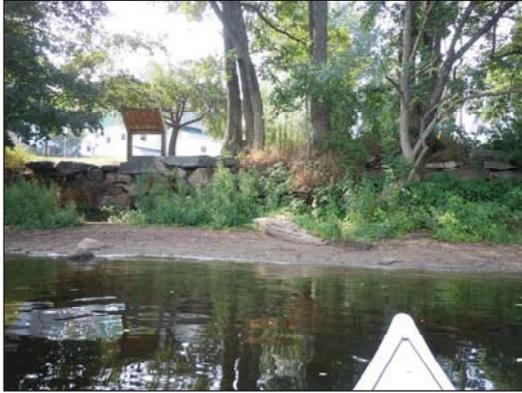
The small park located adjacent to the boat ramp at 39 Bridge Street is separated from the impoundment by a five to six-foot high vertical rock wall. During high water, the base of the wall is below the water level. During dry periods, a narrow beach emerges at the base of the wall. Streams outlet through this area via a 24-inch cast iron pipe and an 18-inch reinforced concrete pipe.

Rock wall and narrow beach along small park

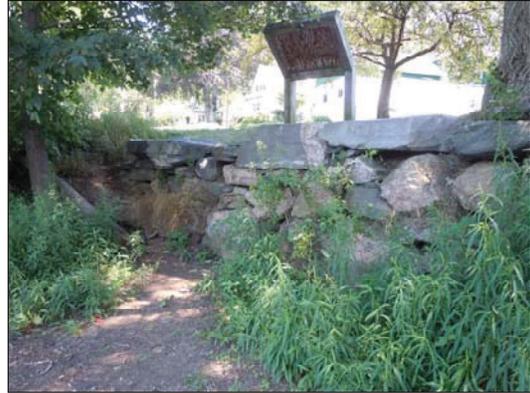
Rock wall along small park

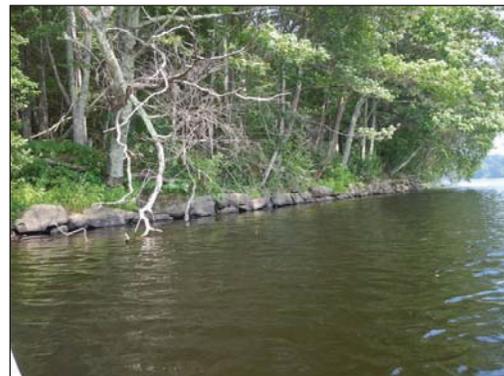
Current view of loose rock shoreline protection

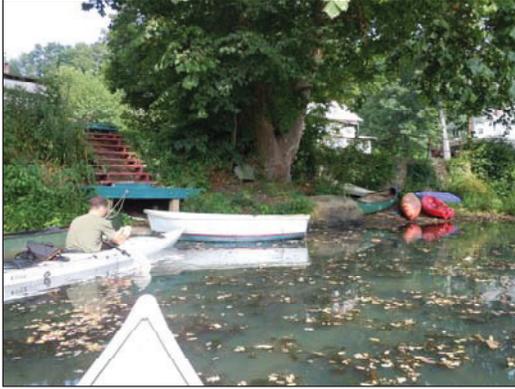
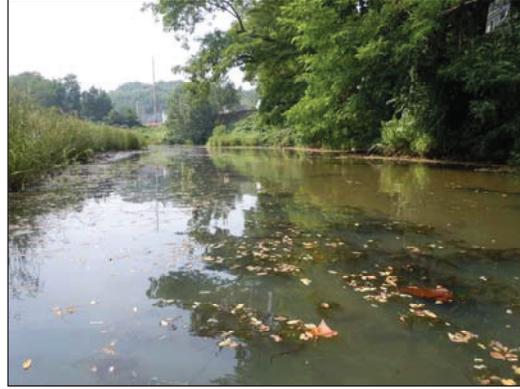
From the cemetery land downstream the large island on the west side of the river, the riverbank is vegetated and lacks any walls or reinforcement. Sections of a concrete retaining wall are present between the west edge of the impoundment and Collins Road in the southwest portion of the study area.

Area of walls and slopes along Torrington Ave

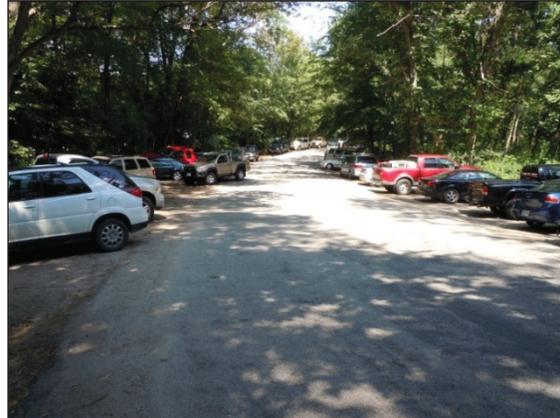
Parking Along Town Bridge Road

- ❑ As many as 35 cars have been observed parked along Town Bridge Road, extending from the bridge to the sewer pumping station. Most of the parking occurs along unpaved areas along the north and south sides of the road. Based on the width of the roadway depicted in Assessor mapping, many (if not all) of the parking “spaces” may be on town-owned land. However, the potential exists for some vehicles to be parked on private property on the north and south sides of the road. Two trash cans are positioned in this area, implying an informal commitment by the town to support recreation in this area.

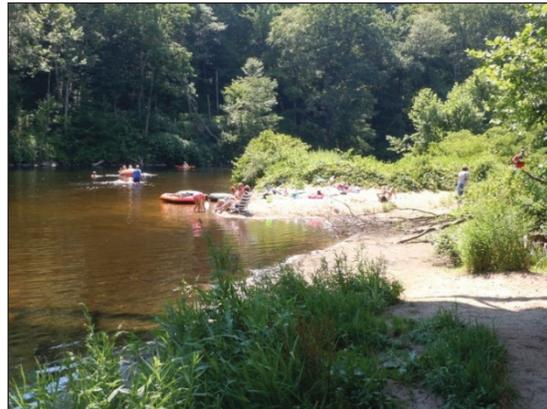
Beaches Near Town Bridge Road

- ❑ Sand and gravel bars on the northeast bank of the river are used as beaches on the upstream and downstream sides of the Town Bridge Road bridge abutment. The upstream beach is a cobble deposit and is much larger than the downstream beach, which is sandy. These areas are used for swimming, canoe and kayak access, use of inflatable boats, sunbathing, picnicking, and even for campfires. Fishing does not appear to be common here possibly as a result of the intense swimming and beach usage.
