Preliminary Structure Report
Bridge No. 05222
November 2014
State Project No. 023-0127

Town Bridge Road over Farmington River
Canton, CT

Prepared By:
TranSystems Corporation
530 Preston Avenue Suite 100
Meriden, CT 06450
TSC Project: P712110001

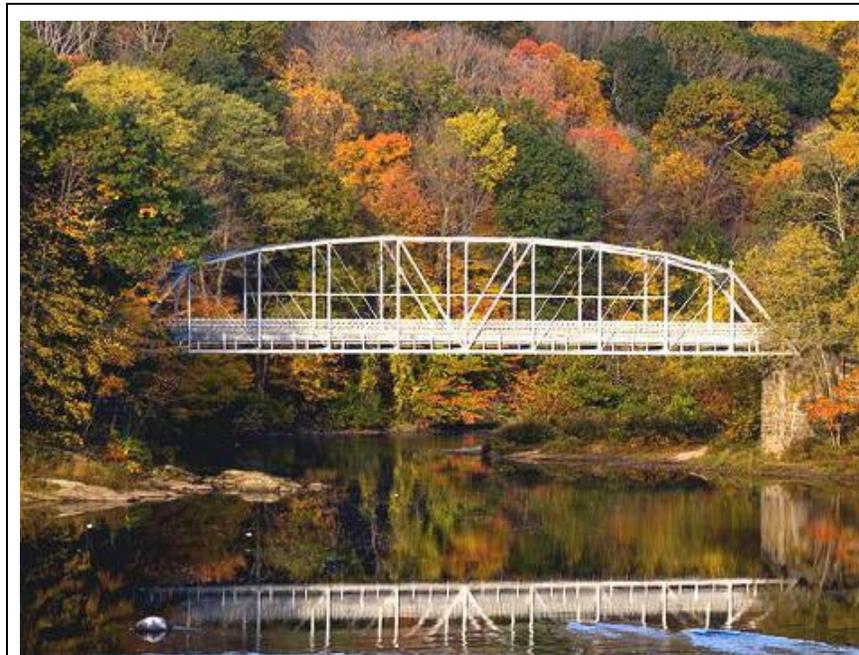
Photo 1: West elevation (looking upstream).

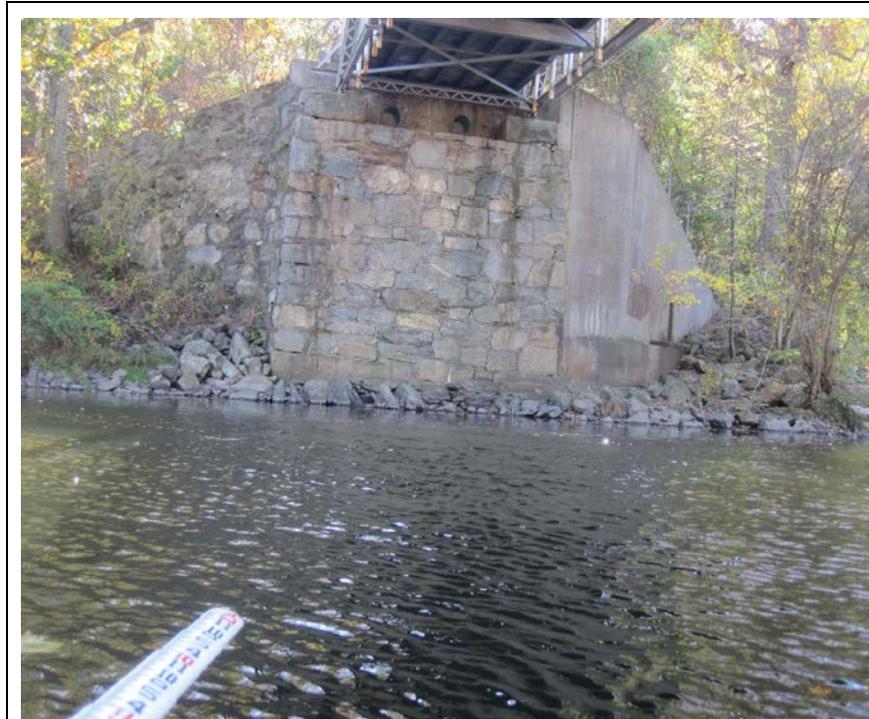
Photo 5: South abutment.

Substructure. The substructure is in satisfactory condition (rated "6"). The stone masonry abutment stems and wingwalls exhibit up to 25% cracked, loose and missing mortar with up to 8" deep penetration between stones. The south abutment stem along the waterline and ends of the northeast and northwest wingwalls has minor voids up to 1' deep between the stones. The southwest reinforced concrete wingwall exhibits moderate scaling; the wall is tipped outward up to 2" over the full height at the south abutment interface. The north abutment concrete backwall has severe scaling with deteriorated concrete along the top edge in Bays 3-6.

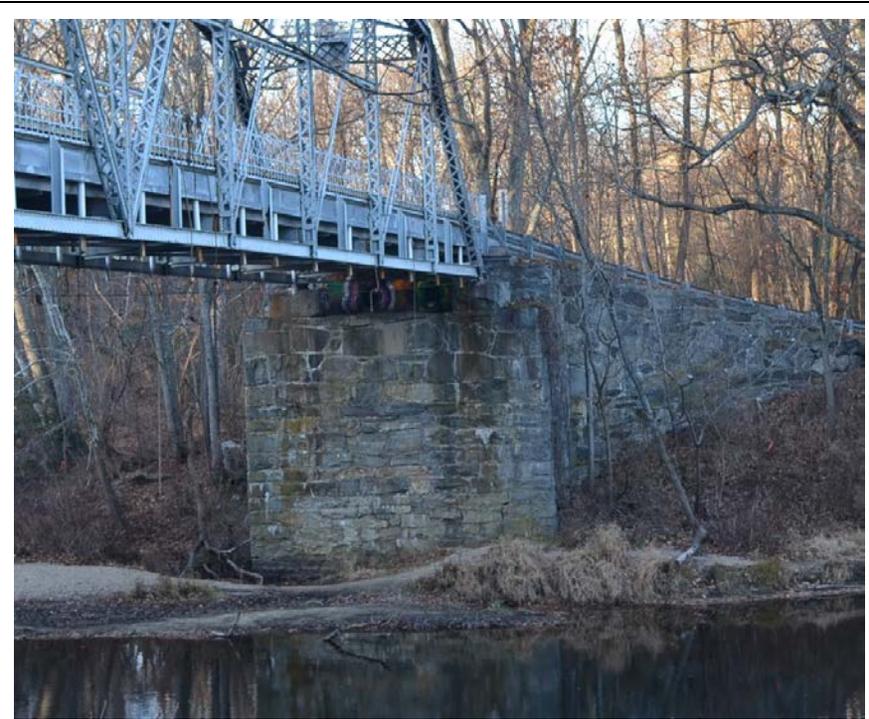
Photo 6: North abutment.

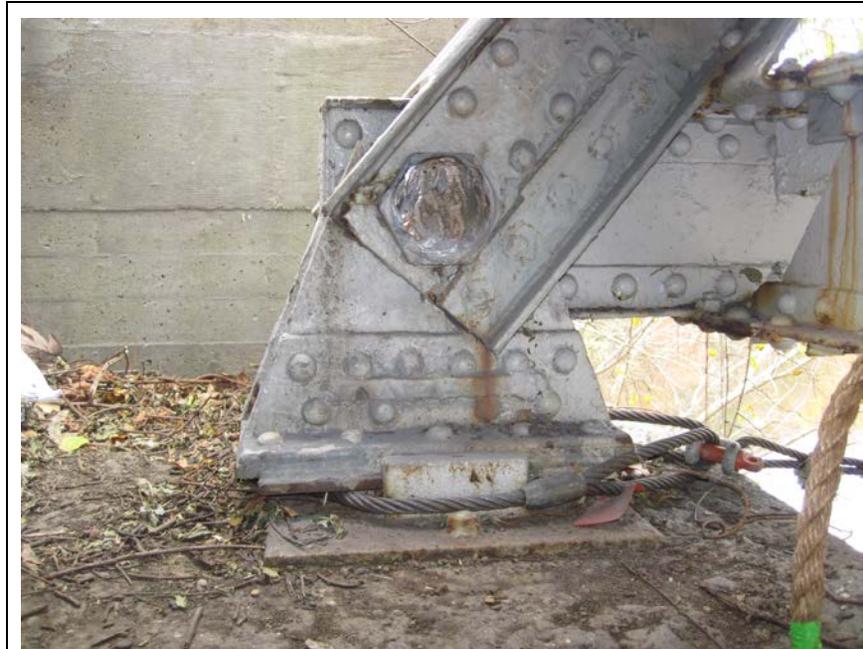
Photo 7: Typical truss expansion bearing at the south abutment.

The truss bearings have up to 3/4" thick impacted rust between shoe plates and truss chord channels. The expansion bearings (south abutment) show evidence of normal movement. The sliding expansion stringer bearings at the south abutment have peeling paint and isolated laminated rust; some bearings are missing keeper plates and show no evidence of movement. The fixed stringer bearings at the north abutment have random rusted off anchor bolts and several anchor bolts with section loss up to 50%.

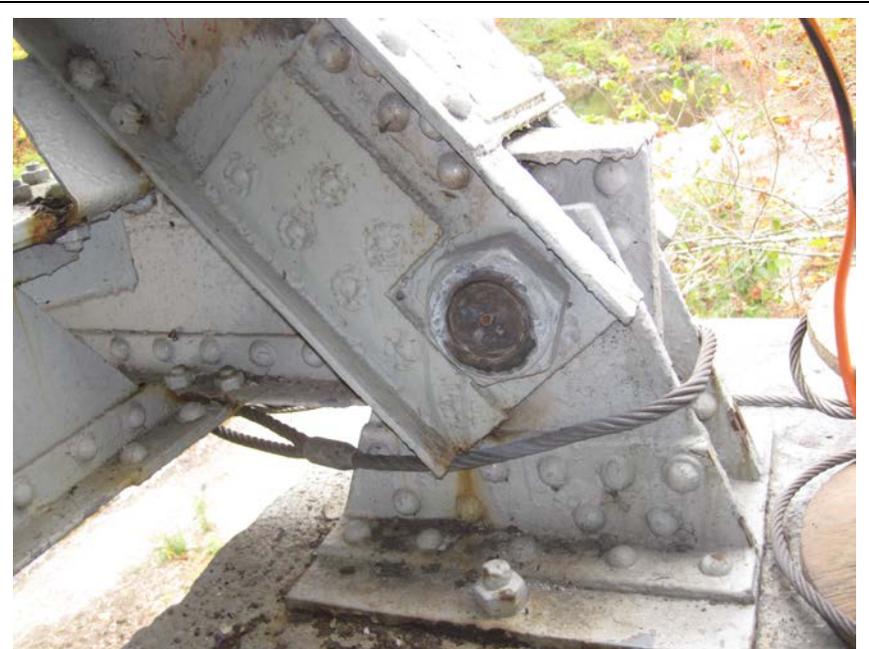
Photo 8: Typical truss fixed bearing at the north abutment.

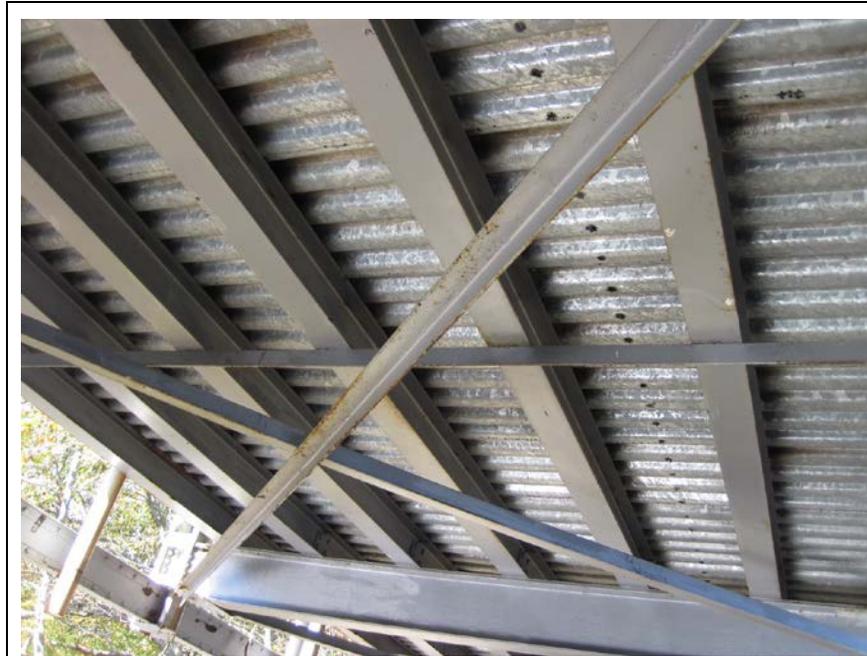
Photo 9: Typical floor system.

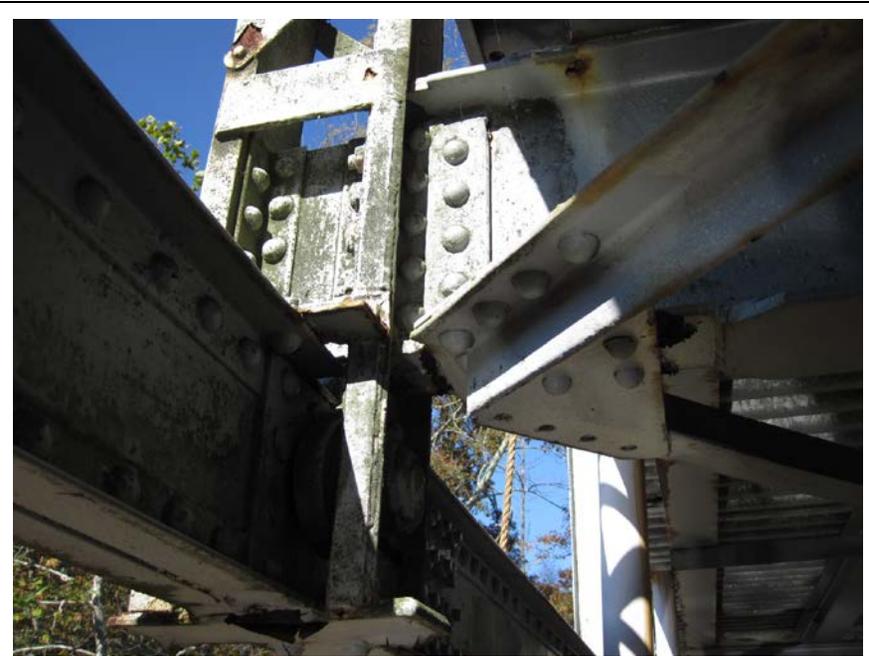
Photo 10: Connection of floorbeam 8 to the west truss. Typical floorbeam and truss connection.

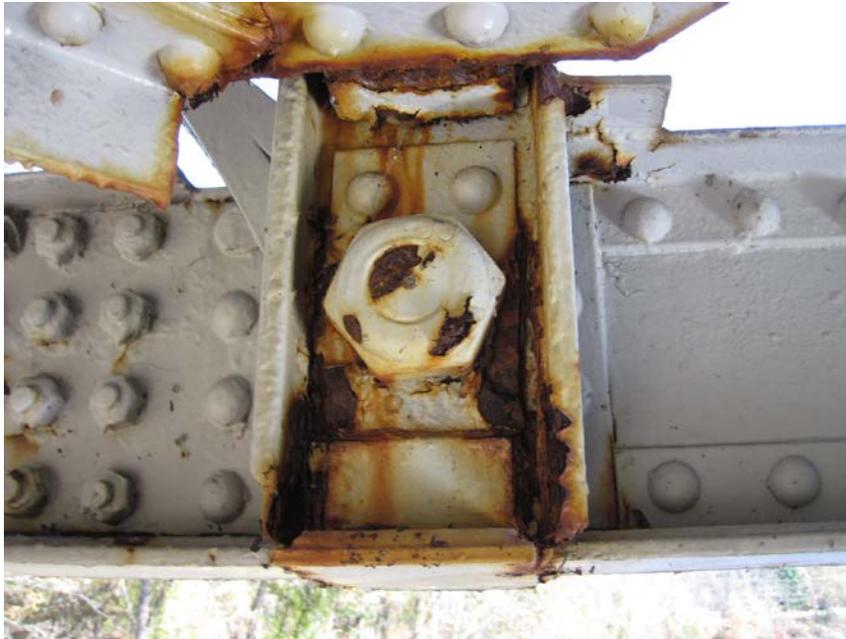
Photo 11: Typical pin connection at bottom chord.

On October 30, 2013, all the truss pins on the bridge were inspected by Team Industrial Inc. using a straight beam ultrasonic testing method. All pins were found to be free of measurable indications (see Appendix F).

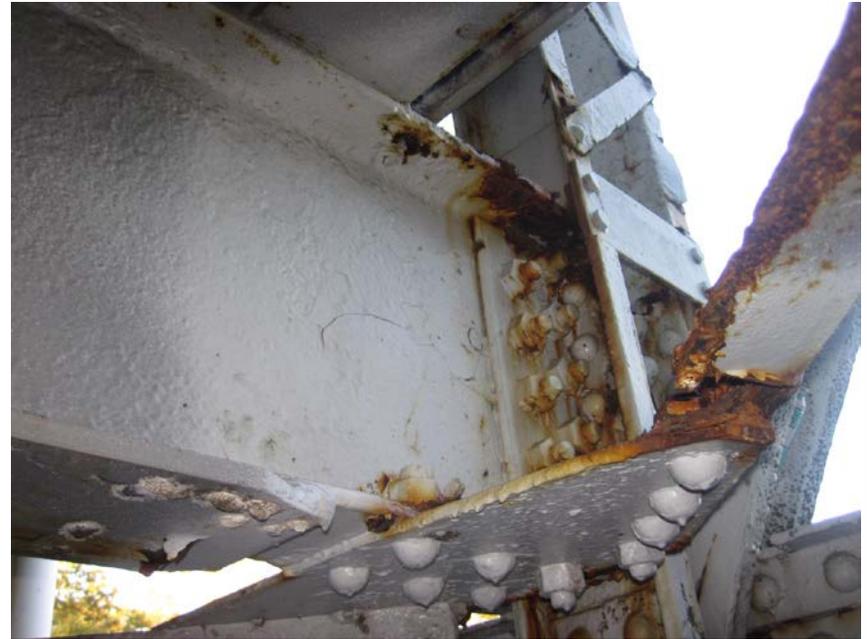
Photo 12: Typical deterioration of floorbeam top flanges at the connection to truss.

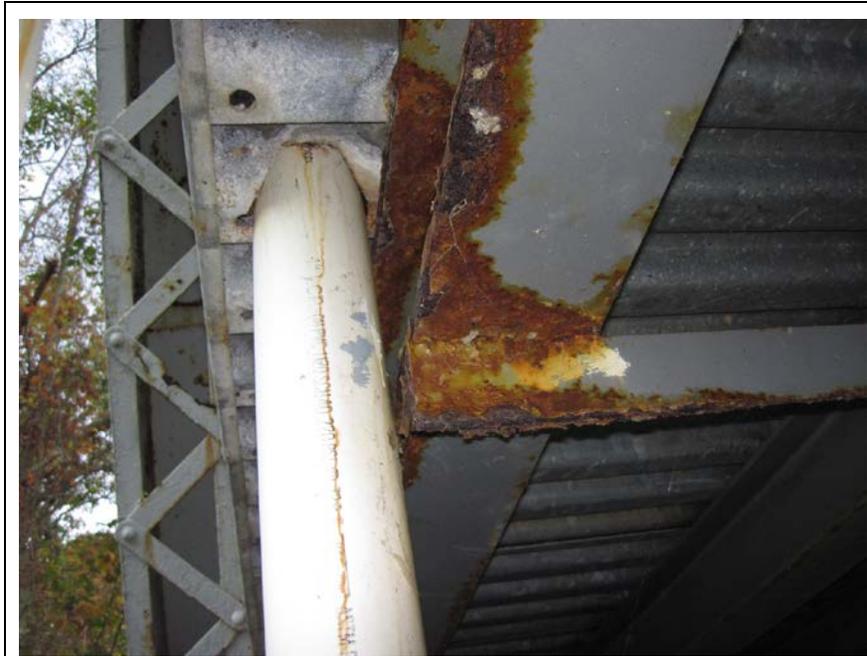
Photo 13: Section loss at stringer 7 between L0 and L1.

The Stringer 4 web at Floorbeam 7 is buckled out-of-plane 1/4" over the full height. The stringer end portions at both abutments exhibit areas of painted over pitting and areas of heavy rust with material section loss up to 28% on the flanges (Stringer 7 @ 1/3 of panel span). The floorbeams typically have deterioration at the ends surrounding the clip angle connection to the vertical truss member. Floorbeams typically have areas of material section loss that is painted over; the paint system is failing and active corrosion is common. The maximum floorbeam section loss is 19% in the web (Floorbeam 8 near East Truss) and 5% in the flanges near midspan.

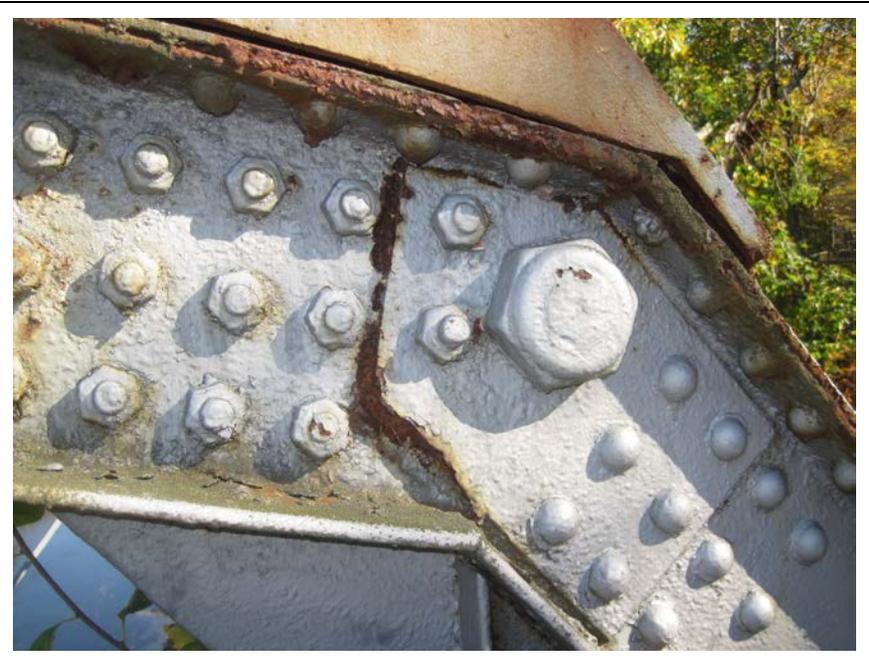
Photo 14: Typical pin connection at top chord.

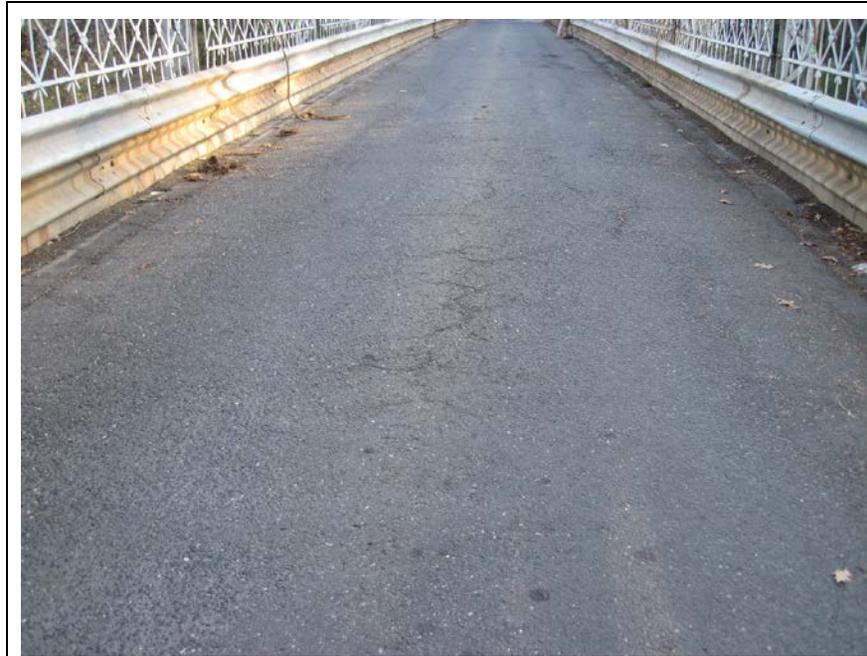
Photo 15: Top of deck looking south. Note cracking in overlay.

Deck. The deck is in good condition (rated "7"). The deck consists of a bituminous-concrete filled galvanized corrugated metal deck. The deck exhibits areas of heavy rust at end dams and there are areas of light rust in the fascia overhang areas at scupper pipes. The bituminous overlay exhibits longitudinal, transverse and map cracks that are up to 3/4" wide, areas of uneven bituminous patches and moderate raveling throughout. There are isolated potholes up to 3' long x 1' wide x 1" deep. The compression seal deck joint at the south abutment has tears up to 21" long, plow damage to the steel extrusion, and there is a 1/2" vertical misalignment between the concrete header and the approach pavement. The backer bar at the eastern side of the south deck joint has fallen down due to deteriorated/broken anchor screws on the underside. The paved over north abutment deck joint has areas of raveling, deteriorated patches and extensive cracking. There is evidence of leakage at the underside of both deck joints. There are galvanized steel curbs/splash guards at the edge of the deck. The ornamental bridge railing along both fascias exhibits minor impact damage with scrapes and bent/broken lattice bars with areas of heavy rust

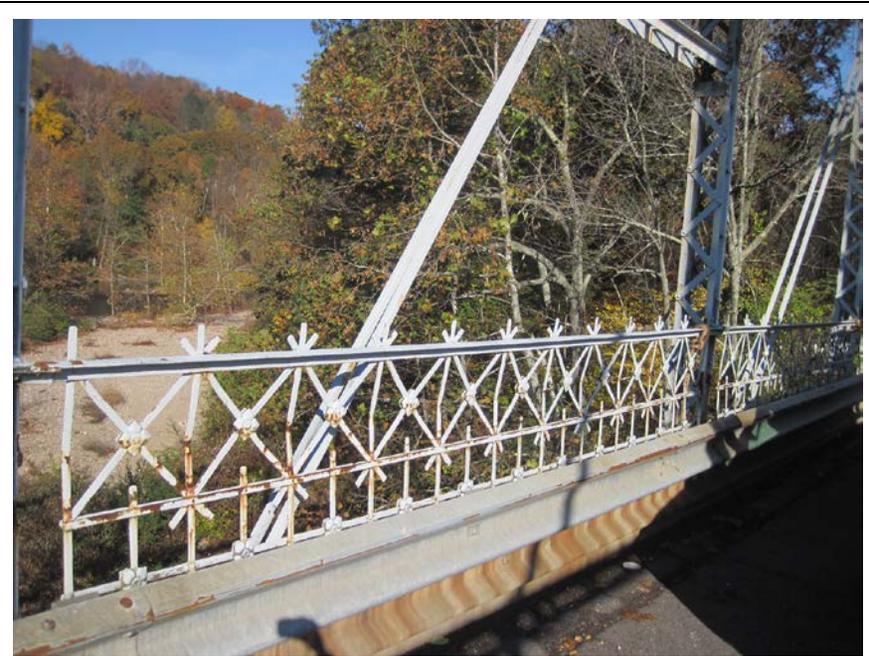
Photo 16: Typical ornamental railing. Note collision damage.
